DEPARTMENT OF TRANSPORTATION

Quality Assurance and Source Inspection

Contract #: 04-0120F4Cty: SF/Ala Rte: 80 PM: 13.2/13.9File #: 69.28**WELDING INSPECTION REPORT****Resident Engineer:** Siegenthaler, Peter**Address:** 333 Burma Road**City:** Oakland, CA 94607**Report No:** WIR-020879**Date Inspected:** 20-Feb-2011**Project Name:** SAS Superstructure**OSM Arrival Time:** 1900**Prime Contractor:** American Bridge/Fluor Enterprises, a JV**OSM Departure Time:** 700**Contractor:** Zhenhua Port Machinery Company, Ltd (ZPMC), Changxing Island **Location:** Shanghai, China**CWI Name:** See below**CWI Present:** Yes No**Inspected CWI report:** Yes No N/A**Rod Oven in Use:** Yes No N/A**Electrode to specification:** Yes No N/A**Weld Procedures Followed:** Yes No N/A**Qualified Welders:** Yes No N/A**Verified Joint Fit-up:** Yes No N/A**Approved Drawings:** Yes No N/A**Approved WPS:** Yes No N/A**Delayed / Cancelled:** Yes No N/A**Bridge No:** 34-0006**Component:** OBG Components**Summary of Items Observed:**

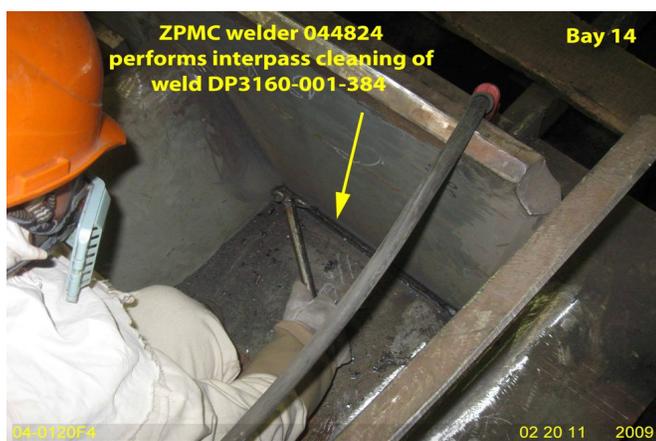
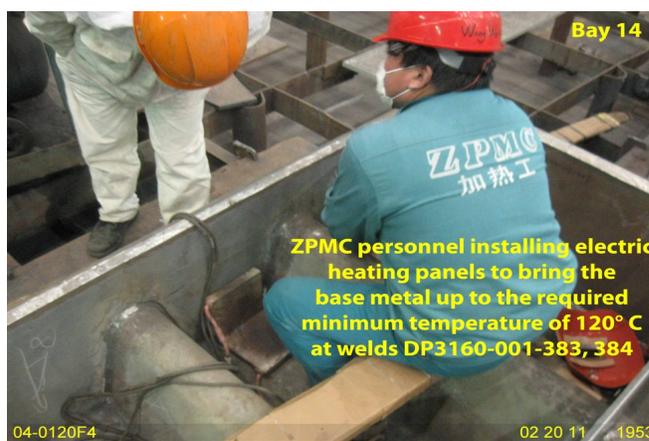
FCAW welding of weld joint DP3160-001-383, 384 located on PCMK OBG 14E, transverse diaphragm to deck plate. Welder was identified as 044824. QC was identified as ZPMC CWI Liu Hua Jie (QC1). Weld variables recorded by QC1 appeared to comply with WPS-B-T-2232-ESAB as verbally identified by QCA1. See photos below of the preheating preparation before welding and interpass cleaning.
