DEPARTMENT OF TRANSPORTATION

Quality Assurance and Source Inspection

Contract #: 04-0120F4Cty: SF/ALA Rte: 80 PM: 13.2/13.9File #: 69.28**WELDING INSPECTION REPORT****Resident Engineer:** Siegenthaler, Peter**Address:** 333 Burma Road**City:** Oakland, CA 94607**Report No:** WIR-020994**Date Inspected:** 20-Feb-2011**Project Name:** SAS Superstructure**OSM Arrival Time:** 1900**Prime Contractor:** American Bridge/Fluor Enterprises, a JV**OSM Departure Time:** 700**Contractor:** Zhenhua Port Machinery Company, Ltd (ZPMC), Changxing Island **Location:** Shanghai China**CWI Name:** See below**CWI Present:** Yes No**Inspected CWI report:** Yes No N/A**Rod Oven in Use:** Yes No N/A**Electrode to specification:** Yes No N/A**Weld Procedures Followed:** Yes No N/A**Qualified Welders:** Yes No N/A**Verified Joint Fit-up:** Yes No N/A**Approved Drawings:** Yes No N/A**Approved WPS:** Yes No N/A**Delayed / Cancelled:** Yes No N/A**Bridge No:** 34-0006**Component:** OBG**Summary of Items Observed:**

WELDING INSPECTION REPORT

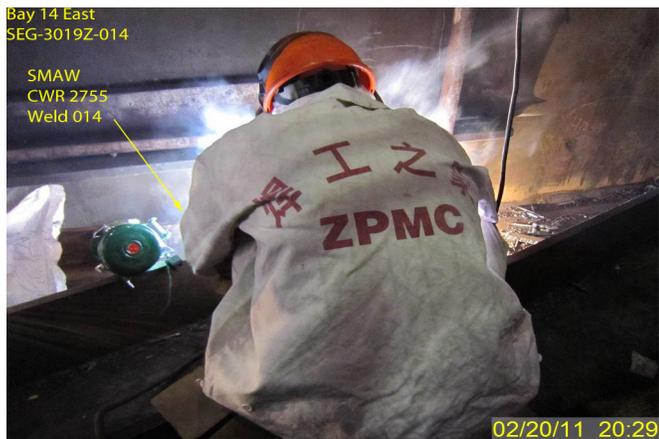
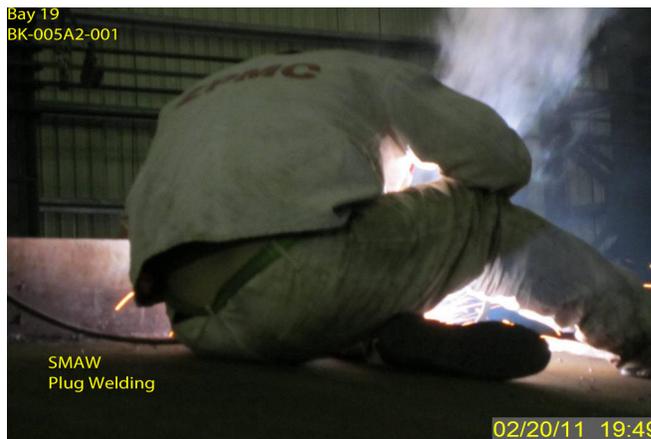
Unless otherwise noted, all work observed on this date appeared to be in general compliance with the applicable contract documents.
