**DEPARTMENT OF TRANSPORTATION**

Contract #: 04-0120F4Cty: SF/ALA Rte: 80 PM: 13.2/13.9File #: 99.28**WELDING INSPECTION REPORT****Resident Engineer:**Siegenthaler, Peter**Address:** 333 Burma Road**City:** Oakland, CA 94607**Report No:** WIR-024637**Date Inspected:** 10-Feb-2011**Project Name:** SAS Superstructure**OSM Arrival Time:** 1500**Prime Contractor:** American Bridge/Fluor Enterprises, a JV**OSM Departure Time:** 300**Contractor:** Zhenhua Port Machinery Company, Ltd (ZPMC) Changxing Island **Location:** Shanghai, China**CWI Name:** Sha Zhi**CWI Present:** Yes No**Inspected CWI report:** Yes No N/A**Rod Oven in Use:** Yes No N/A**Electrode to specification:** Yes No N/A**Weld Procedures Followed:** Yes No N/A**Qualified Welders:** Yes No N/A**Verified Joint Fit-up:** Yes No N/A**Approved Drawings:** Yes No N/A**Approved WPS:** Yes No N/A**Delayed / Cancelled:** Yes No N/A**Bridge No:** 34-0006**Component:** OBG**Summary of Items Observed:**

OBG Bay 14

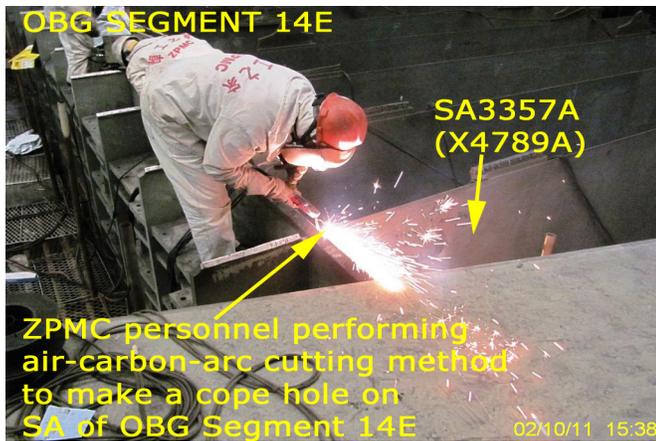
During random in process observations of OBG Segment 14E, this QA inspector observed ZPMC personnel performing air-carbon-arc cutting method to make proper radius of cope hole on SA of OBG Segment 14E. This QA performed Visual Testing (VT) of the cope radius and found they appeared to be in general compliance with the applicable contract documents. For more details please see photo below:
