**DEPARTMENT OF TRANSPORTATION**

Contract #: 04-0120F4Cty: SF/ALA Rte: 80 PM: 13.2/13.9File #: 69.28**WELDING INSPECTION REPORT****Resident Engineer:** Siegenthaler, Peter**Address:** 333 Burma Road**City:** Oakland, CA 94607**Report No:** WIR-021485**Date Inspected:** 03-Mar-2011**Project Name:** SAS Superstructure**OSM Arrival Time:** 1500**Prime Contractor:** American Bridge/Fluor Enterprises, a JV**OSM Departure Time:** 300**Contractor:** Zhenhua Port Machinery Company, Ltd (ZPMC), Changxing Island **Location:** Shanghai, China**CWI Name:** See Below**CWI Present:** Yes No**Inspected CWI report:** Yes No N/A**Rod Oven in Use:** Yes No N/A**Electrode to specification:** Yes No N/A**Weld Procedures Followed:** Yes No N/A**Qualified Welders:** Yes No N/A**Verified Joint Fit-up:** Yes No N/A**Approved Drawings:** Yes No N/A**Approved WPS:** Yes No N/A**Delayed / Cancelled:** Yes No N/A**Bridge No:** 34-0006**Component:** OBG**Summary of Items Observed:**

# WELDING INSPECTION REPORT

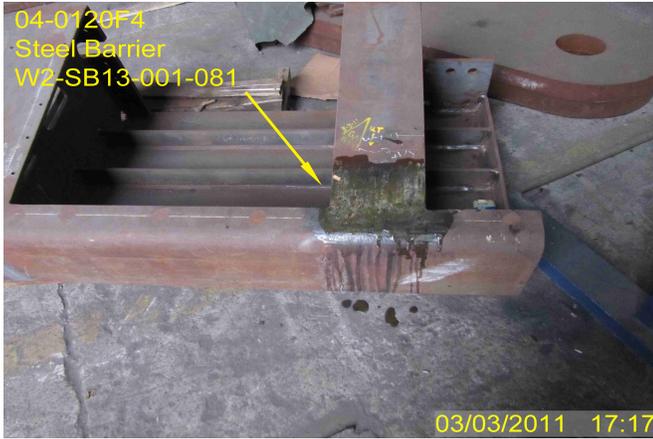
Item 1  
W2-SB13-001-081

At the time of the verification it was noted that the above component appeared to be within compliance of the contract documents. See Caltrans Ultrasonic Test Report (TL6027), dated 03-03-2011 for additional information.

The following digital picture illustrates weld W2-SB13-001-081.

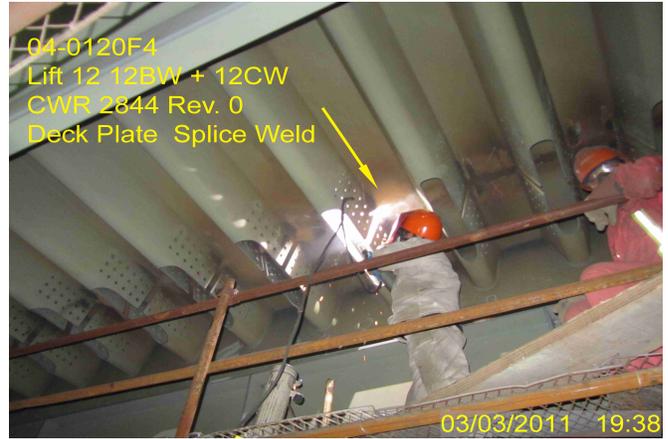
CWR2844 Rev. 0  
12BW + 12CW  
Weld- Deck Plate Splice  
WPS-345-SMAW-4G-FCM-Repair-1  
Welder-046709  
4G/SMAW/CJP

The following digital picture illustrates welding deck plate critical weld repair.
