**DEPARTMENT OF TRANSPORTATION**

Contract #: 04-0120F4Cty: SF/ALA Rte: 80 PM: 13.2/13.9File #: 69.28**WELDING INSPECTION REPORT****Resident Engineer:** Siegenthaler, Peter**Address:** 333 Burma Road**City:** Oakland, CA 94607**Report No:** WIR-021496**Date Inspected:** 06-Mar-2011**Project Name:** SAS Superstructure**OSM Arrival Time:** 700**Prime Contractor:** American Bridge/Fluor Enterprises, a JV**OSM Departure Time:** 1900**Contractor:** Zhenhua Port Machinery Company, Ltd (ZPMC), Changxing Island **Location:** Shanghai, China**CWI Name:** An Qing Xiang.**CWI Present:** Yes No**Inspected CWI report:** Yes No N/A**Rod Oven in Use:** Yes No N/A**Electrode to specification:** Yes No N/A**Weld Procedures Followed:** Yes No N/A**Qualified Welders:** Yes No N/A**Verified Joint Fit-up:** Yes No N/A**Approved Drawings:** Yes No N/A**Approved WPS:** Yes No N/A**Delayed / Cancelled:** Yes No N/A**Bridge No:** 34-0006**Component:** OBG components.**Summary of Items Observed:**

# WELDING INSPECTION REPORT

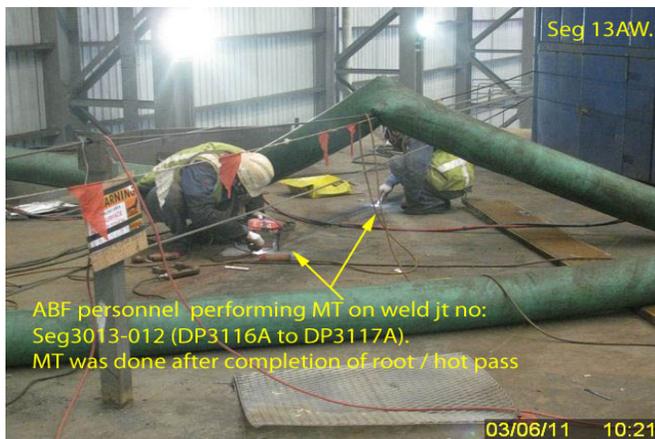
This QA Inspector observed ABF MT personnel performing Magnetic Particle Testing (MT) on weld joint no: Seg3013-012 [Deck Panel (DP) 3116A to DP3117A, CJP splice joint]. MT was observed to be done after completion of root / hot pass. ZPMC QC was identified as Liu Feng. See attached photo for further information.
