DEPARTMENT OF TRANSPORTATION

Quality Assurance and Source Inspection

Contract #: 04-0120F4Cty: SF/ALA Rte: 80 PM: 13.2/13.9File #: 69.28**WELDING INSPECTION REPORT****Resident Engineer:** Siegenthaler, Peter**Address:** 333 Burma Road**City:** Oakland, CA 94607**Report No:** WIR-021759**Date Inspected:** 11-Mar-2011**Project Name:** SAS Superstructure**OSM Arrival Time:** 700**Prime Contractor:** American Bridge/Fluor Enterprises, a JV**OSM Departure Time:** 1900**Contractor:** Zhenhua Port Machinery Company, Ltd (ZPMC), Changxing Island **Location:** Shanghai, China**CWI Name:** Xu tao**CWI Present:** Yes No**Inspected CWI report:** Yes No N/A**Rod Oven in Use:** Yes No N/A**Electrode to specification:** Yes No N/A**Weld Procedures Followed:** Yes No N/A**Qualified Welders:** Yes No N/A**Verified Joint Fit-up:** Yes No N/A**Approved Drawings:** Yes No N/A**Approved WPS:** Yes No N/A**Delayed / Cancelled:** Yes No N/A**Bridge No:** 34-0006**Component:** OBG Components**Summary of Items Observed:**

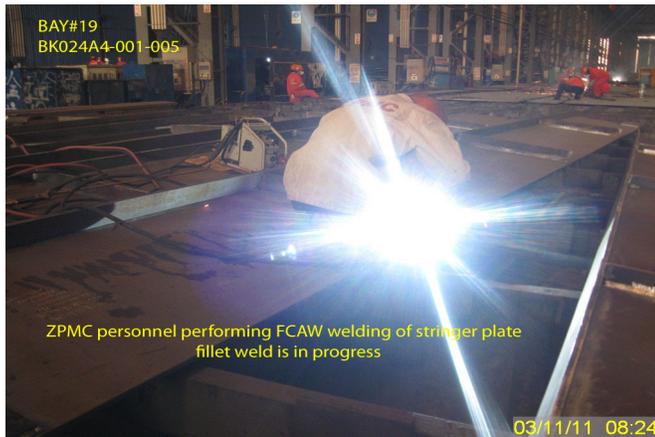
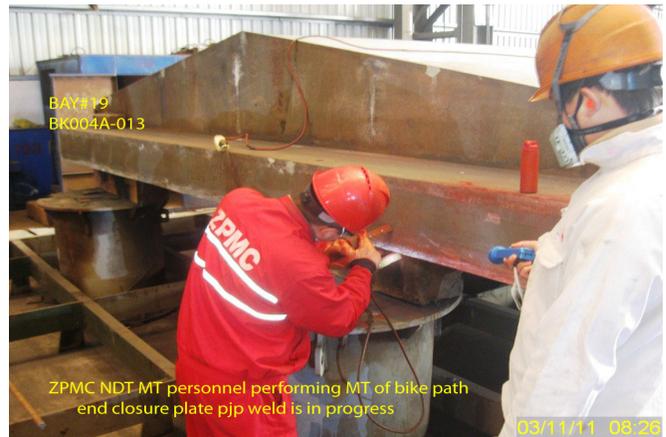
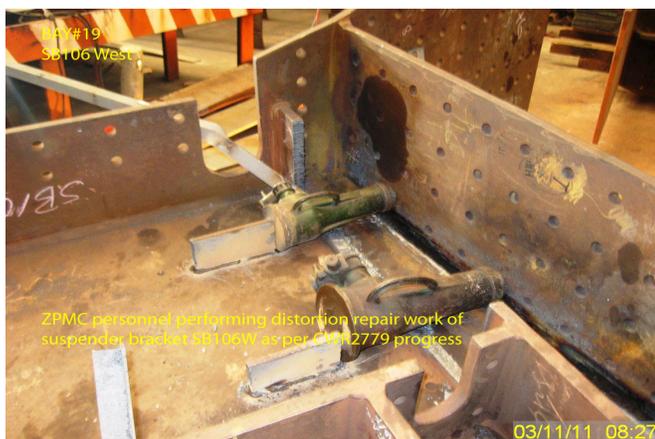
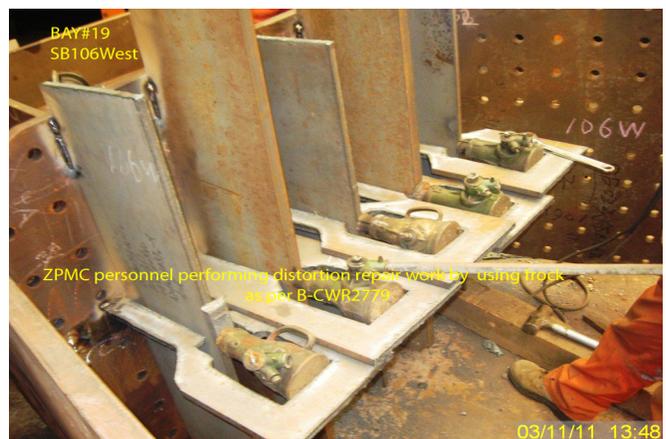
FCAW welding of weld is identified as 2F-005/006 of BK024A4-001 for BK0024-001. The welder is identified as 062734. ZPMC QC is identified as Mr.Guo xing hui. The welding variables recorded by QC are appeared to comply with the WPS-B-T-2132-ESAB.

FCAW welding of weld is identified as 1G-011 of SA6031 for SA6031. The welder is identified as 067806. ZPMC QC is identified as Mr.Peng wen jun. The welding variables recorded by QC are appeared to comply with the WPS-B-T-2231-ESAB.

ZPMC QC NDT MT personnel performing magnetic particle testing of BK004A-013 end closure plate PJP weld is in progress.

ZPMC QC NDT MT personnel performing magnetic particle testing of CWR locations on BK004B-001 bottom cover plate plug weld is in progress.

ZPMC personnel start their distortion repair work of Suspender bracket SB106West as per approved B-CWR2779.

ZPMC personnel performing flame cutting to increase the cope hole size from 25mm to 35 ~40mm in size.

ZPMC personnel performing Heat straightening of suspender bracket SB106West as per approved B-CWR2779 and HSR1(B)-9955 in progress.
