**DEPARTMENT OF TRANSPORTATION**

Contract #: 04-0120F4Cty: SF/ALA Rte: 80 PM: 13.2/13.9File #: 69.28**WELDING INSPECTION REPORT****Resident Engineer:** Siegenthaler, Peter**Address:** 333 Burma Road**City:** Oakland, CA 94607**Report No:** WIR-022043**Date Inspected:** 19-Mar-2011**Project Name:** SAS Superstructure**OSM Arrival Time:** 700**Prime Contractor:** American Bridge/Fluor Enterprises, a JV**OSM Departure Time:** 1900**Contractor:** Zhenhua Port Machinery Company, Ltd (ZPMC), Changxing Island **Location:** Shanghai, China**CWI Name:** Liu Hua Jie.**CWI Present:** Yes No**Inspected CWI report:** Yes No N/A**Rod Oven in Use:** Yes No N/A**Electrode to specification:** Yes No N/A**Weld Procedures Followed:** Yes No N/A**Qualified Welders:** Yes No N/A**Verified Joint Fit-up:** Yes No N/A**Approved Drawings:** Yes No N/A**Approved WPS:** Yes No N/A**Delayed / Cancelled:** Yes No N/A**Bridge No:** 34-0006**Component:** OBG components.**Summary of Items Observed:**

OBG Seg 13AW:

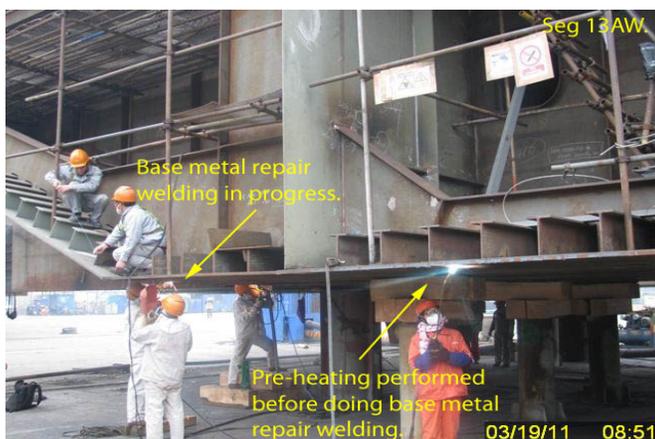
ZPMC personnel performing base metal repair welding on Bottom Panel after removal of temporary attachments. Welding process was identified as SMAW. Welders were identified as 069683 and 200113 and were observed welding in 4G position. Repair welding was done as per Critical Welding Repair Report (CWR): 2841 Rev-0. Magnetic Particle Testing was observed to be done (by ABF) before performing base metal repair welding. See attached photo for further information.
