Contract #: 04-0120F4Cty: SF/ALA Rte: 80 PM: 13.2/13.9File #: 69.28**WELDING INSPECTION REPORT****Resident Engineer:** Siegenthaler, Peter**Address:** 333 Burma Road**City:** Oakland, CA 94607**Report No:** WIR-022142**Date Inspected:** 27-Mar-2011**Project Name:** SAS Superstructure**OSM Arrival Time:** 700**Prime Contractor:** American Bridge/Fluor Enterprises, a JV**OSM Departure Time:** 1900**Contractor:** Zhenhua Port Machinery Company, Ltd (ZPMC), Changxing Island **Location:** Shanghai, China**CWI Name:** Mr. Liu hua jie**CWI Present:** Yes No**Inspected CWI report:** Yes No N/A**Rod Oven in Use:** Yes No N/A**Electrode to specification:** Yes No N/A**Weld Procedures Followed:** Yes No N/A**Qualified Welders:** Yes No N/A**Verified Joint Fit-up:** Yes No N/A**Approved Drawings:** Yes No N/A**Approved WPS:** Yes No N/A**Delayed / Cancelled:** Yes No N/A**Bridge No:** 34-0006**Component:** Orthotropic Box Girder (OBG)**Summary of Items Observed:**

OBG Trial Assembly open yard.

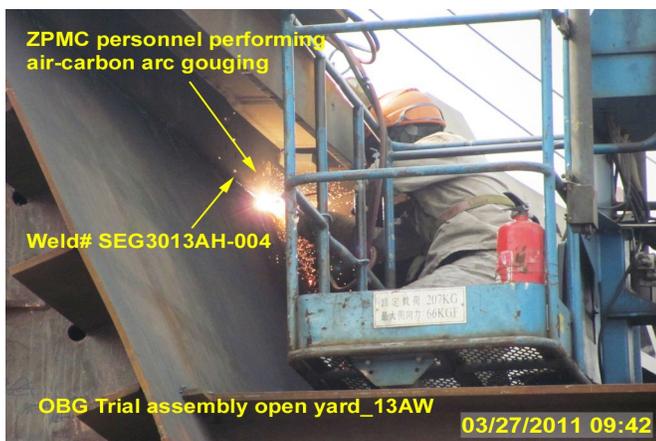
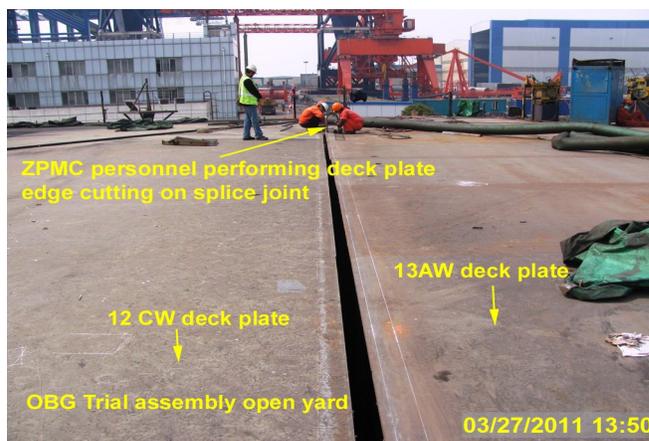
ZPMC personnel performing air-carbon arc gouging on weld joint identified as SEG3013AH-004 at Panel point no. 119.35 counter weight side. See attached photos for further details.

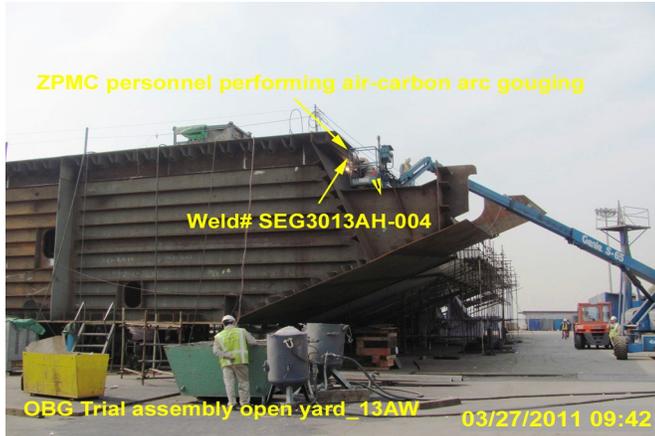
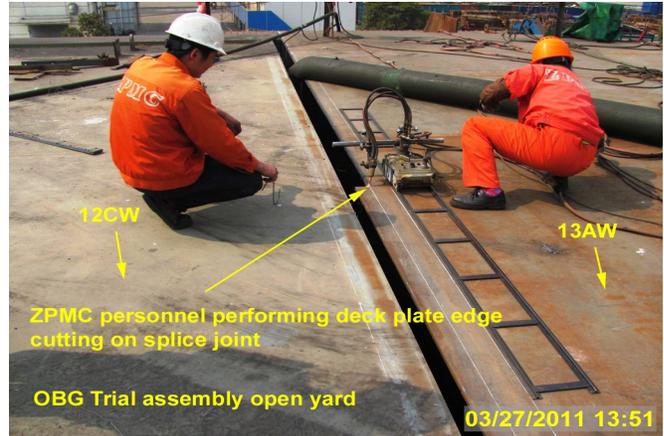
ZPMC personnel performing deck plate edge cutting on splice joint by using automatic flame gas cutting device. See attached photos for further details.
