Contract #: 04-0120F4Cty: SF/ALA Rte: 80 PM: 13.2/13.9File #: 99.28**WELDING INSPECTION REPORT****Resident Engineer:** Siegenthaler, Peter**Address:** 333 Burma Road**City:** Oakland, CA 94607**Report No:** WIR-022160**Date Inspected:** 22-Mar-2011**Project Name:** SAS Superstructure**OSM Arrival Time:** 700**Prime Contractor:** American Bridge/Fluor Enterprises, a JV**OSM Departure Time:** 1900**Contractor:** Zhenhua Port Machinery Company, Ltd (ZPMC) Chanxing Island**Location:** Shanghai, China**CWI Name:** Mr. ZHU ZHONG HAI**CWI Present:** Yes No**Inspected CWI report:** Yes No N/A**Rod Oven in Use:** Yes No N/A**Electrode to specification:** Yes No N/A**Weld Procedures Followed:** Yes No N/A**Qualified Welders:** Yes No N/A**Verified Joint Fit-up:** Yes No N/A**Approved Drawings:** Yes No N/A**Approved WPS:** Yes No N/A**Delayed / Cancelled:** Yes No N/A**Bridge No:** 34-0006**Component:** OBG Segment**Summary of Items Observed:**

WELDING INSPECTION REPORT

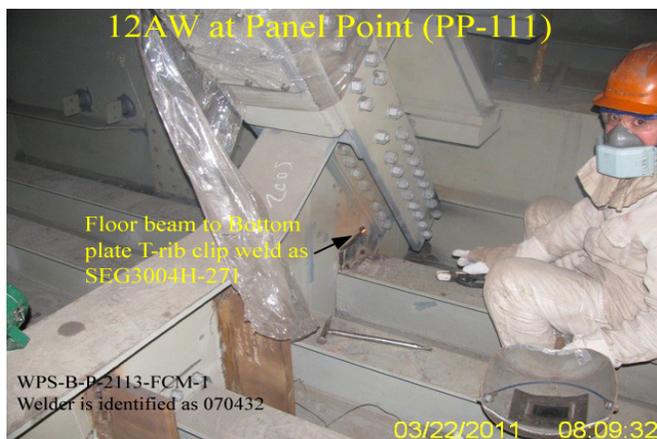
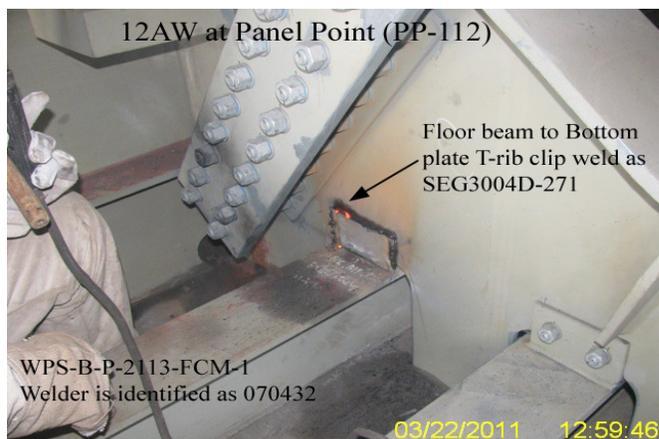
ZPMC welding personnel performing Shielded Metal Arc Welding of Fillet welds joining the floor beam to bottom plate T-rib clip weld joint located on 12AW at Panel Point (PP-111). The weld is designated as SEG3004H-271. The welder is identified as 070432. ZPMC QC Mr. ZHANG QIANG was onsite monitoring the welding variables. The inprocess Shielded Metal Arc Welding appears to be progressing in compliance with WPS-B-P-2113-FCM-1. Further weld detail mention in attached picture.

ZPMC welding personnel performing Shielded Metal Arc Welding of Fillet welds joining the floor beam to bottom plate T-rib clip weld joint located on 12AW at Panel Point (PP-112). The weld is designated as SEG3004D-271. The welder is identified as 070432. ZPMC QC Mr. ZHANG QIANG was onsite monitoring the welding variables. The inprocess Shielded Metal Arc Welding appears to be progressing in compliance with WPS-B-P-2113-FCM-1. Further weld detail mention in attached picture.
