Contract #: 04-0120F4Cty: SF/ALA Rte: 80 PM: 13.2/13.9File #: 69.28**WELDING INSPECTION REPORT****Resident Engineer:** Siegenthaler, Peter**Address:** 333 Burma Road**City:** Oakland, CA 94607**Report No:** WIR-022202**Date Inspected:** 12-Mar-2011**Project Name:** SAS Superstructure**OSM Arrival Time:** 1500**Prime Contractor:** American Bridge/Fluor Enterprises, a JV**OSM Departure Time:** 300**Contractor:** Zhenhua Port Machinery Company, Ltd (ZPMC), Changxing Island **Location:** Shanghai, China**CWI Name:** See Below**CWI Present:** Yes No**Inspected CWI report:** Yes No N/A**Rod Oven in Use:** Yes No N/A**Electrode to specification:** Yes No N/A**Weld Procedures Followed:** Yes No N/A**Qualified Welders:** Yes No N/A**Verified Joint Fit-up:** Yes No N/A**Approved Drawings:** Yes No N/A**Approved WPS:** Yes No N/A**Delayed / Cancelled:** Yes No N/A**Bridge No:** 34-0006**Component:** OBG**Summary of Items Observed:**

# WELDING INSPECTION REPORT

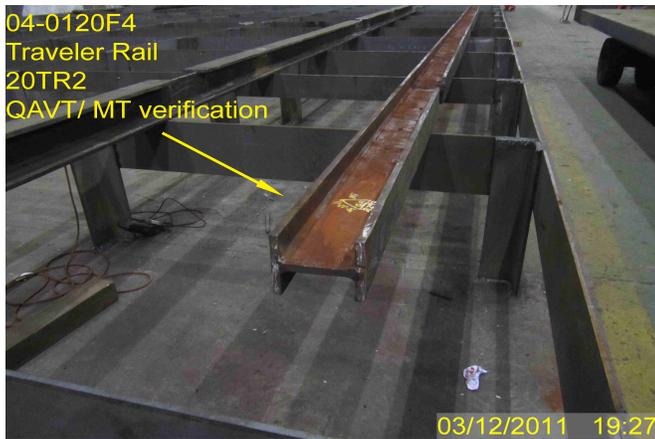
20TR2-039-009, 013, 015, 011, 017

At the time of the verification it was noted that the above component appeared to be within compliance of the contract documents. See Caltrans Magnetic Particle Test Report (TL6028), dated 03-12-2011 for additional information.

The following digital picture illustrates traveler rail 20TR2 QAVT/ MT verification.
