DEPARTMENT OF TRANSPORTATION

Quality Assurance and Source Inspection

Contract #: 04-0120F4Cty: SF/ALA Rte: 80 PM: 13.2/13.9File #: 69.28**WELDING INSPECTION REPORT****Resident Engineer:** Siegenthaler, Peter**Address:** 333 Burma Road**City:** Oakland, CA 94607**Report No:** WIR-022263**Date Inspected:** 31-Mar-2011**Project Name:** SAS Superstructure**OSM Arrival Time:** 700**Prime Contractor:** American Bridge/Fluor Enterprises, a JV**OSM Departure Time:** 1900**Contractor:** Zhenhua Port Machinery Company, Ltd (ZPMC), Changxing Island **Location:** Shanghai, China**CWI Name:** Mr. Shi zhi**CWI Present:** Yes No**Inspected CWI report:** Yes No N/A**Rod Oven in Use:** Yes No N/A**Electrode to specification:** Yes No N/A**Weld Procedures Followed:** Yes No N/A**Qualified Welders:** Yes No N/A**Verified Joint Fit-up:** Yes No N/A**Approved Drawings:** Yes No N/A**Approved WPS:** Yes No N/A**Delayed / Cancelled:** Yes No N/A**Bridge No:** 34-0006**Component:** Orthotropic Box Girder (OBG)**Summary of Items Observed:**

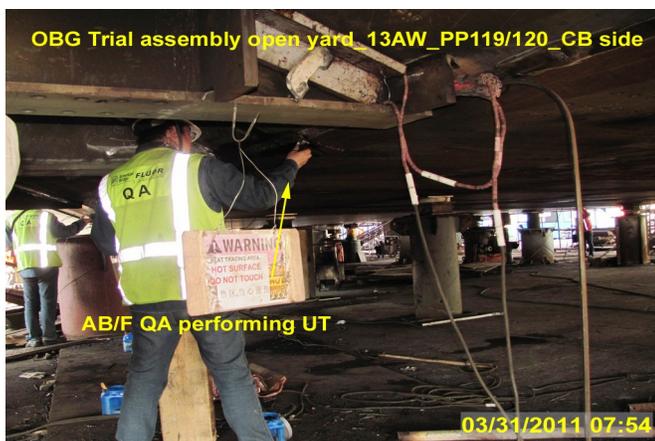
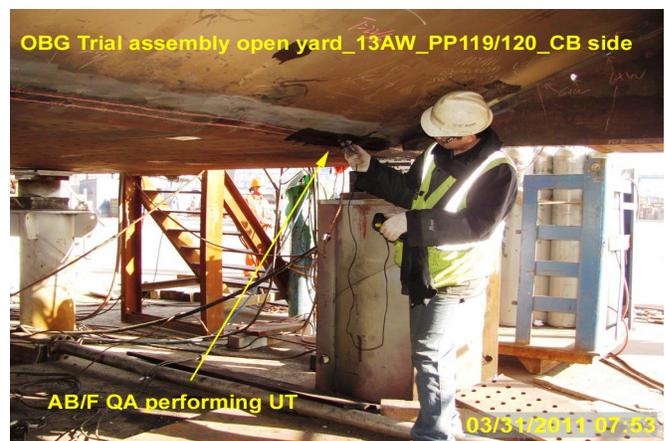
AB/F QA Inspectors performing Ultrasonic Testing for the side panel to bottom panel at Panel point 119 cross beam side. See attached photos for further information.
