DEPARTMENT OF TRANSPORTATION

Quality Assurance and Source Inspection

WELDING INSPECTION REPORT

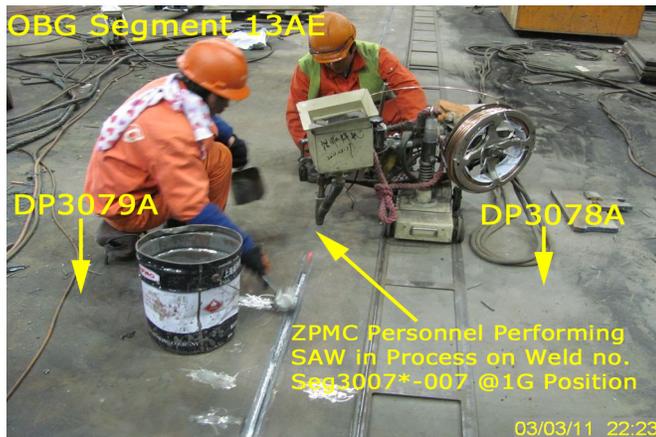
This QA Inspector observed the welding operation per the SAW process on a weld joint identified as SEG3007*-007 located on Deck Panel of the OBG Segment 13AE. The welder is identified as 058100. ZPMC Quality Control (QC) is identified as Mr. Zhan Hai Feng. The welding variables recorded by QC appeared to comply with WPS-B-T-2221-B-L2c-S-2. For more details please see attached photo below:
