**DEPARTMENT OF TRANSPORTATION**

Contract #: 04-0120F4Cty: SF/ALA Rte: 80 PM: 13.2/13.9File #: 99.28**WELDING INSPECTION REPORT****Resident Engineer:** Siegenthaler, Peter**Address:** 333 Burma Road**City:** Oakland, CA 94607**Report No:** WIR-026369**Date Inspected:** 26-Mar-2011**Project Name:** SAS Superstructure**OSM Arrival Time:** 1500**Prime Contractor:** American Bridge/Fluor Enterprises, a JV**OSM Departure Time:** 300**Contractor:** Zhenhua Port Machinery Company, Ltd (ZPMC) Changxing Island **Location:** Shanghai, China**CWI Name:** Lv Li Qing**CWI Present:** Yes No**Inspected CWI report:** Yes No N/A**Rod Oven in Use:** Yes No N/A**Electrode to specification:** Yes No N/A**Weld Procedures Followed:** Yes No N/A**Qualified Welders:** Yes No N/A**Verified Joint Fit-up:** Yes No N/A**Approved Drawings:** Yes No N/A**Approved WPS:** Yes No N/A**Delayed / Cancelled:** Yes No N/A**Bridge No:** 34-0006**Component:** OBG**Summary of Items Observed:**

## WELDING INSPECTION REPORT

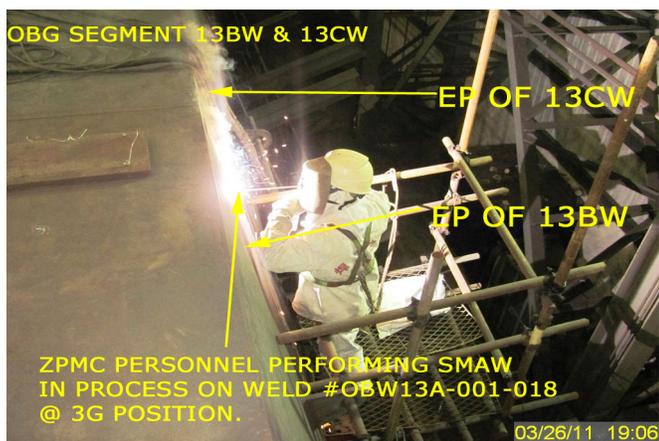
This QA Inspector observed the welding operation per the SMAW process on a weld joint identified as OBW13A-018 located on Edge Plate to Edge Plate of the 13BW and 13CW. The welder is identified as 066673. ZPMC Quality Control (QC) is identified as Mr. Wang Xiang Pin. The welding variables recorded by QC appeared to comply with WPS-B-P-2213-Tc-U4b-FCM-1. For more details please see attached photo below:

Unless otherwise noted, all work observed on this date appeared to be in general compliance with the applicable contract documents.
