DEPARTMENT OF TRANSPORTATION

Quality Assurance and Source Inspection

Contract #: 04-0120F4Cty: SF/ALA Rte: 80 PM: 13.2/13.9File #: 99.28**WELDING INSPECTION REPORT****Resident Engineer:** Siegenthaler, Peter**Address:** 333 Burma Road**City:** Oakland, CA 94607**Report No:** WIR-026385**Date Inspected:** 08-Mar-2011**Project Name:** SAS Superstructure**OSM Arrival Time:** 1500**Prime Contractor:** American Bridge/Fluor Enterprises, a JV**OSM Departure Time:** 300**Contractor:** Zhenhua Port Machinery Company, Ltd (ZPMC) Changxing Island **Location:** Shanghai, China**CWI Name:** Lv Li Qing**CWI Present:** Yes No**Inspected CWI report:** Yes No N/A**Rod Oven in Use:** Yes No N/A**Electrode to specification:** Yes No N/A**Weld Procedures Followed:** Yes No N/A**Qualified Welders:** Yes No N/A**Verified Joint Fit-up:** Yes No N/A**Approved Drawings:** Yes No N/A**Approved WPS:** Yes No N/A**Delayed / Cancelled:** Yes No N/A**Bridge No:** 34-0006**Component:** OBG**Summary of Items Observed:**

WELDING INSPECTION REPORT

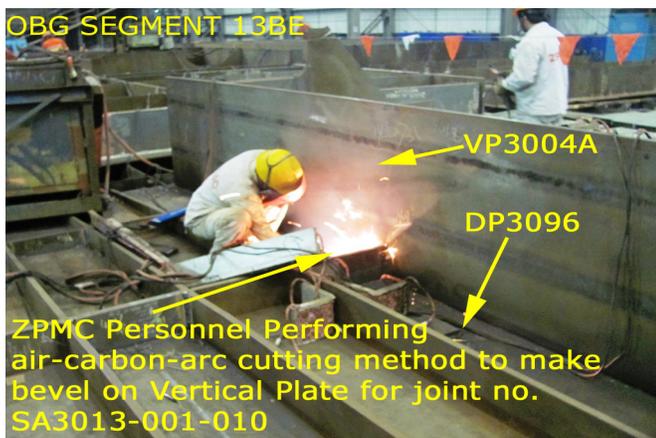
During random in process observations of OBG Segment 13BE, this QA inspector observed ZPMC personnel performing air-carbon-arc-cutting method to make a bevel on vertical plate for joint identified as SA3013-001-010 located on Vertical Plate (VP3004A) to Deck Plate (DP3096) of OBG Segment 13BE. This QA performed Visual Testing (VT) of the joint and found that appeared to be in general compliance with the applicable contract documents. For more details please see attached photo below:
