Contract #: 04-0120F4Cty: SF/ALA Rte: 80 PM: 13.2/13.9File #: 69.28**WELDING INSPECTION REPORT****Resident Engineer:** Siegenthaler, Peter**Address:** 333 Burma Road**City:** Oakland, CA 94607**Report No:** WIR-022563**Date Inspected:** 07-Apr-2011**Project Name:** SAS Superstructure**OSM Arrival Time:** 700**Prime Contractor:** American Bridge/Fluor Enterprises, a JV**OSM Departure Time:** 1900**Contractor:** Zhenhua Port Machinery Company, Ltd (ZPMC), Changxing Island **Location:** Shanghai, China**CWI Name:** Zhu Zhong Hai**CWI Present:** Yes No**Inspected CWI report:** Yes No N/A**Rod Oven in Use:** Yes No N/A**Electrode to specification:** Yes No N/A**Weld Procedures Followed:** Yes No N/A**Qualified Welders:** Yes No N/A**Verified Joint Fit-up:** Yes No N/A**Approved Drawings:** Yes No N/A**Approved WPS:** Yes No N/A**Delayed / Cancelled:** Yes No N/A**Bridge No:** 34-0006**Component:** OBG Segments**Summary of Items Observed:**

OBG Trial Assembly Yard

Segment 13AE

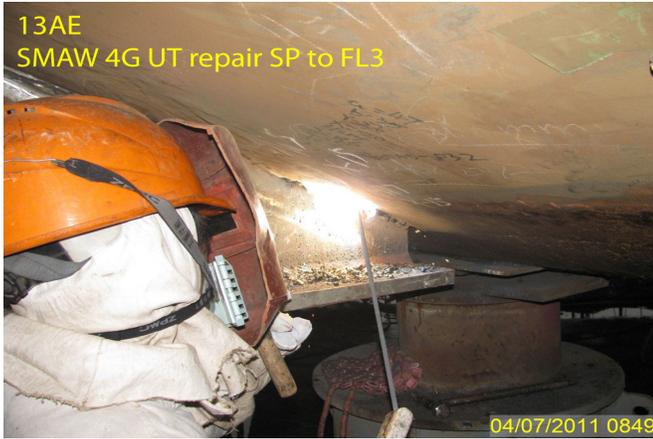
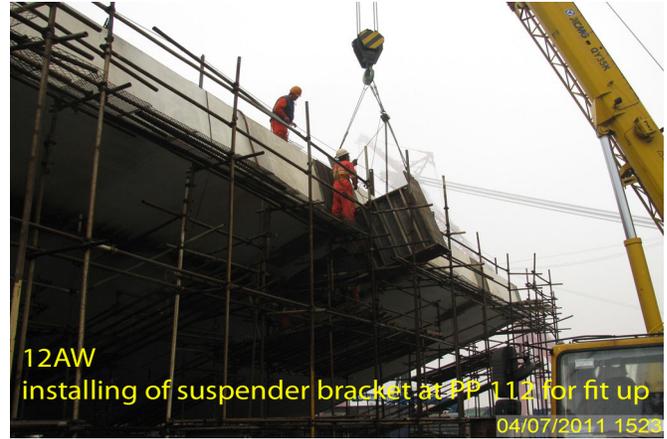
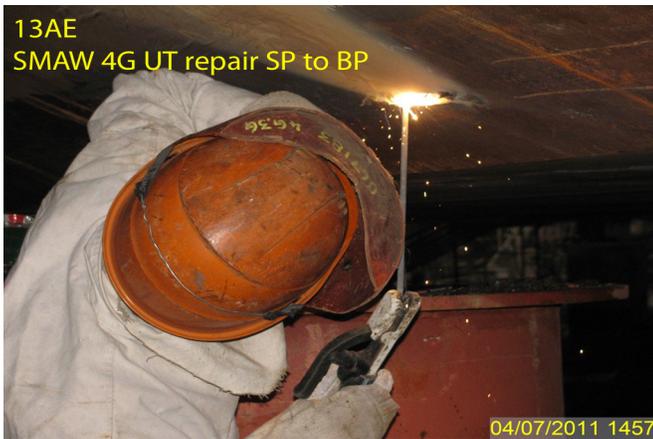
This QA Inspector observed Shielded Metal Arc Welding (SMAW) in progress of a UT repair on a Complete Joint Penetration (CJP) weld joint. The Weld joint is designated SEG3007AD-032, Side Plate to FL3. The welder is identified as #067183 and was observed welding in the 4G (overhead) position using approved Welding Procedure Specification WPS-345-SMAW-4G (4F)-FCM-repair-1 for WR20507.

This QA Inspector observed Shielded Metal Arc Welding (SMAW) in progress of a Complete Joint Penetration (CJP) weld joint. The Weld joint is designated SEG3007J-013, Floor Beam to Deck Plate. The welder is identified as #068917 and was observed welding in the 4G (overhead) position using approved Welding Procedure Specification WPS-B-P-2214-TC-U4b-FCM-1.

This QA Inspector observed installation of high strength bolts for the Deck Plate U-rib bolted splice plates at segment transverse splice.

This QA Inspector observed fit up of Suspender Bracket at panel point 112.
