Contract #: 04-0120F4Cty: SF/ALA Rte: 80 PM: 13.2/13.9File #: 69.28**WELDING INSPECTION REPORT****Resident Engineer:** Siegenthaler, Peter**Address:** 333 Burma Road**City:** Oakland, CA 94607**Report No:** WIR-022679**Date Inspected:** 16-Apr-2011**Project Name:** SAS Superstructure**OSM Arrival Time:** 1500**Prime Contractor:** American Bridge/Fluor Enterprises, a JV**OSM Departure Time:** 300**Contractor:** Zhenhua Port Machinery Company, Ltd (ZPMC), Changxing Island **Location:** Shanghai, China**CWI Name:** Mr. Sha Zhi ZPMC**CWI Present:** Yes No**Inspected CWI report:** Yes No N/A**Rod Oven in Use:** Yes No N/A**Electrode to specification:** Yes No N/A**Weld Procedures Followed:** Yes No N/A**Qualified Welders:** Yes No N/A**Verified Joint Fit-up:** Yes No N/A**Approved Drawings:** Yes No N/A**Approved WPS:** Yes No N/A**Delayed / Cancelled:** Yes No N/A**Bridge No:** 34-0006**Component:** TA Yard OBG 12/13E**Summary of Items Observed:**

TRIAL ASSEMBLY

WELDING INSPECTION REPORT

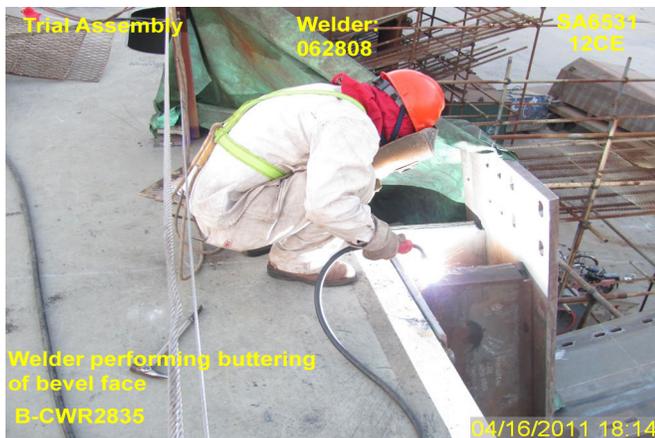
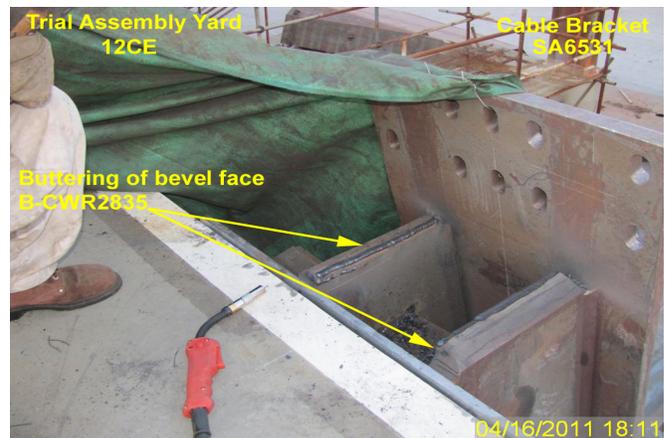
FCAW welding of complete joint penetration weld joint(s) located on lift 12BE, SA6530 buttering of CJP Bevel Face weld number(s) 005, 015. Welder is identified as welder no. 062806. The welding variables recorded by ZPMC QC identified as Wang Xiang Pin appeared to comply with applicable WPS(s)

FCAW welding of complete joint penetration weld joint(s) located on lift 12BE, SA6530 buttering of CJP Bevel Face weld number(s) 005, 015. Welder is identified as welder no. 062808. The welding variables recorded by ZPMC QC identified as Wang Xiang Pin appeared to comply with applicable WPS(s) WPS-345-FCAW-1G-ESAB-REP and B-CWR2835.

SMAW welding of complete joint penetration weld joint(s) located on lift 13CE, SEG3011H Floor Beam Edge Plate Splice weld number(s) 166. Welder is identified as welder no. 051359. The welding variables recorded by ZPMC QC identified as Wang Xiang Pin appeared to comply with applicable WPS(s) WPS(s) WPS-345-SMAW-4G (4F)-FCM-Repair and B-WR20574.

SMAW welding of complete joint penetration weld joint(s) located on lift 13CE, SEG3011H Floor Beam Edge Plate Splice weld number(s) 161 and 162. Welder is identified as welder no. 050969. The welding variables recorded by ZPMC QC identified as Wang Xiang Pin appeared to comply with applicable WPS(s) WPS(s) WPS-345-SMAW-4G (4F)-FCM-Repair and B-WR20574.

SMAW welding of complete joint penetration weld joint(s) located on lift 13AE, SEG3007B Rib Stiffener to Edge Plate weld number(s) 257 and 267. Welder is identified as welder no. 050242. The welding variables recorded by ZPMC QC identified as Wang Xiang Pin appeared to comply with applicable WPS(s) WPS-345-SMAW-4G (4F)-FCM-Repair and B-WR20534.

Unless otherwise noted, all work observed on this date appeared to generally comply with applicable contract documents.
