**DEPARTMENT OF TRANSPORTATION**

Quality Assurance and Source Inspection

Contract #: 04-0120F4Cty: SF/ALA Rte: 80 PM: 13.2/13.9File #: 69.28**WELDING INSPECTION REPORT****Resident Engineer:** Siegenthaler, Peter**Address:** 333 Burma Road**City:** Oakland, CA 94607**Report No:** WIR-023798**Date Inspected:** 13-Apr-2011**Project Name:** SAS Superstructure**OSM Arrival Time:** 700**Prime Contractor:** American Bridge/Fluor Enterprises, a JV**OSM Departure Time:** 1900**Contractor:** Zhenhua Port Machinery Company, Ltd (ZPMC), Changxing Island **Location:** Shanghai, China**CWI Name:** Xu Le Feng**CWI Present:** Yes No**Inspected CWI report:** Yes No N/A**Rod Oven in Use:** Yes No N/A**Electrode to specification:** Yes No N/A**Weld Procedures Followed:** Yes No N/A**Qualified Welders:** Yes No N/A**Verified Joint Fit-up:** Yes No N/A**Approved Drawings:** Yes No N/A**Approved WPS:** Yes No N/A**Delayed / Cancelled:** Yes No N/A**Bridge No:** 34-0006**Component:** OBG & TOWER Components**Summary of Items Observed:**

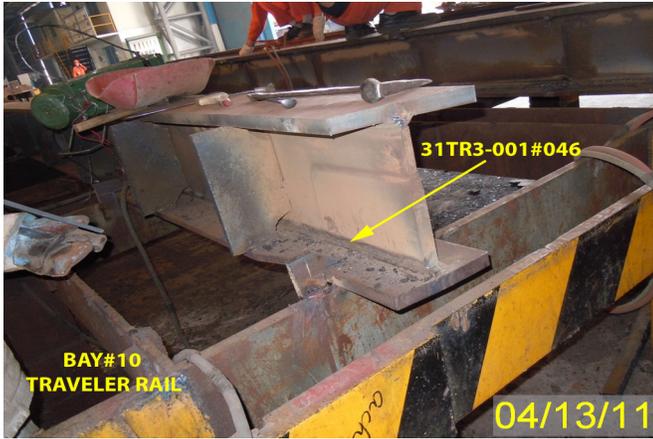
Weld joint #046 located on Traveler Rail 31TR3-001. Welder is identified as 050038. ZPMC Quality Control (QC) Inspector is identified as Sun Zi Wang. The welding variables recorded by QC appeared to comply with the WPS-B-P-2212-Tc-U5b. (See attached Photo)

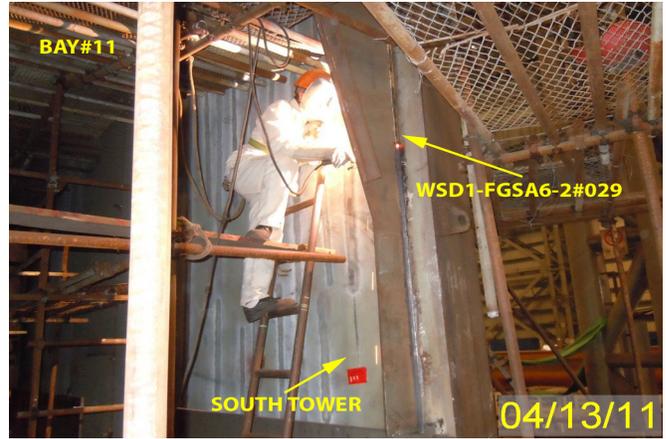
Weld joint #029 located on Lift-6 Tower head component WSD1-FGSA6-2. Welder is identified as 040614. ZPMC Quality Control (QC) Inspector is identified as Mao Bin Bin. The welding variables recorded by QC appeared to comply with the WPS-B-P-2313-Tc-P4. (See attached photo)
