Contract #: 04-0120F4Cty: SF/ALA Rte: 80 PM: 13.2/13.9File #: 69.28**WELDING INSPECTION REPORT****Resident Engineer:** Siegenthaler, Peter**Address:** 333 Burma Road**City:** Oakland, CA 94607**Report No:** WIR-024400**Date Inspected:** 30-Apr-2011**Project Name:** SAS Superstructure**OSM Arrival Time:** 700**Prime Contractor:** American Bridge/Fluor Enterprises, a JV**OSM Departure Time:** 1900**Contractor:** Zhenhua Port Machinery Company, Ltd (ZPMC), Changxing Island **Location:** Shanghai, China

Bridge No: 34-0006**Component:** Orthotropic Box Girder (OBG)**Summary of Items Observed:**

OBG Trial Assembly

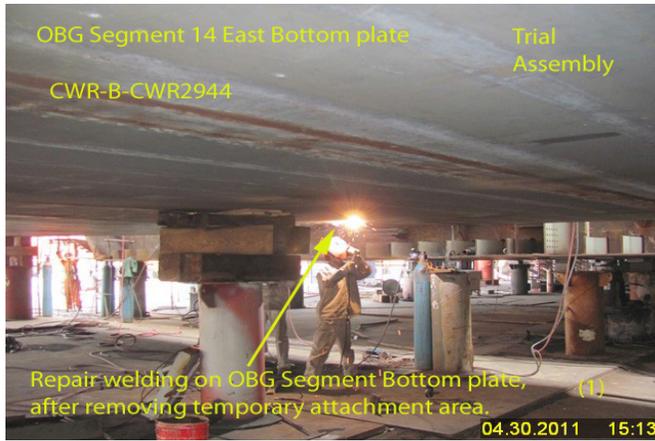
This QA Inspector observed ZPMC qualified welding personnel identified as 068917 Perform Shielded Metal Arc Welding (SMAW) on OBG Segment 14 East Bottom plate, after removing temporary attachment area. ZPMC CWI Identified as Lv Li Qing with Critical welding repair report CWR-B-CWR2944. The welding parameters as measured using QC's calibrated instrument appeared to be in general compliance with WPS-345-SMAW-4G (4F)-FCM-Repair-1. For more information see attached picture number 1.
