DEPARTMENT OF TRANSPORTATION

Contract #: 04-0120F4Cty: SF/ALA Rte: 80 PM: 13.2/13.9File #: 99.28**WELDING INSPECTION REPORT****Resident Engineer:** Siegenthaler, Peter**Address:** 333 Burma Road**City:** Oakland, CA 94607**Report No:** WIR-026347**Date Inspected:** 14-Apr-2011**Project Name:** SAS Superstructure**OSM Arrival Time:** 1500**Prime Contractor:** American Bridge/Fluor Enterprises, a JV**OSM Departure Time:** 300**Contractor:** Zhenhua Port Machinery Company, Ltd (ZPMC) Changxing Island **Location:** Shanghai, China**CWI Name:** Lv Li Qing**CWI Present:** Yes No**Inspected CWI report:** Yes No N/A**Rod Oven in Use:** Yes No N/A**Electrode to specification:** Yes No N/A**Weld Procedures Followed:** Yes No N/A**Qualified Welders:** Yes No N/A**Verified Joint Fit-up:** Yes No N/A**Approved Drawings:** Yes No N/A**Approved WPS:** Yes No N/A**Delayed / Cancelled:** Yes No N/A**Bridge No:** 34-0006**Component:** OBG**Summary of Items Observed:**

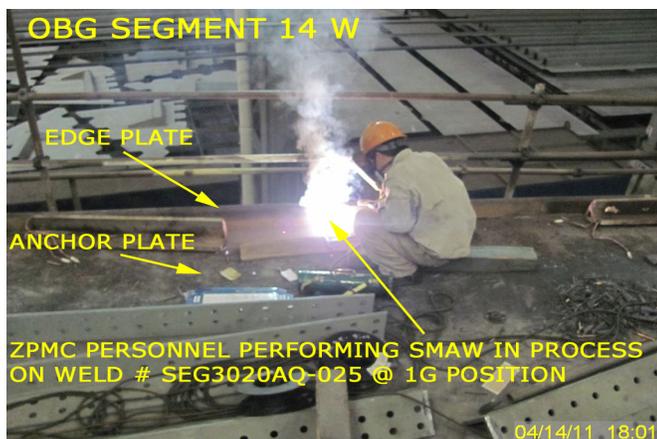
This QA Inspector observed the welding operation per the SMAW process on a weld joint identified as SEG3020AQ-025 located on edge plate to anchor plate of the OBG Segment 14W. The welder is identified as 066361. ZPMC Quality Control (QC) is identified as Mr. An Qing Xiang. The welding variables recorded by QC appeared to comply with WPS-345-SMAW-1G (1F)-FCM-Repair and B-CWR-2923. For more details please see attached photo below:
