Contract #: 04-0120F4Cty: SF/ALA Rte: 80 PM: 13.2/13.9File #: 69.28**WELDING INSPECTION REPORT****Resident Engineer:**Siegenthaler, Peter**Address:** 333 Burma Road**City:** Oakland, CA 94607**Report No:** WIR-023409**Date Inspected:** 08-May-2011**Project Name:** SAS Superstructure**OSM Arrival Time:** 700**Prime Contractor:** American Bridge/Fluor Enterprises, a JV**OSM Departure Time:** 1900**Contractor:** Zhenhua Port Machinery Company, Ltd (ZPMC), Changxing Island **Location:** Shanghai,China**CWI Name:** Liu Hua Jie/Lv Li Qing**CWI Present:** Yes No**Inspected CWI report:** Yes No N/A**Rod Oven in Use:** Yes No N/A**Electrode to specification:** Yes No N/A**Weld Procedures Followed:** Yes No N/A**Qualified Welders:** Yes No N/A**Verified Joint Fit-up:** Yes No N/A**Approved Drawings:** Yes No N/A**Approved WPS:** Yes No N/A**Delayed / Cancelled:** Yes No N/A**Bridge No:** 34-0006**Component:** OBG**Summary of Items Observed:**

OBG Trial Assembly

WELDING INSPECTION REPORT

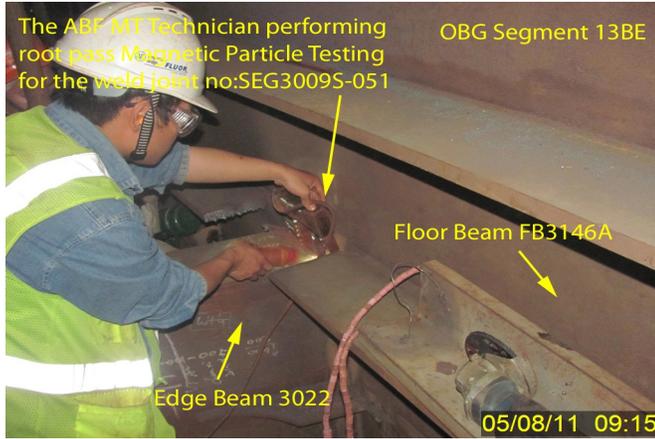
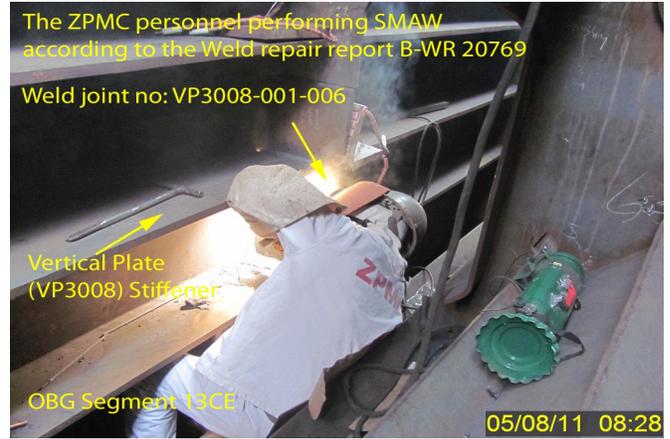
SMAW welding of weld joint No: VP3008-001-006 located on OBG Segment 13CE Vertical Panel stiffener. Welder is identified as #066258. ZPMC CWI is identified as Mr. Lv Li Qing. Welding was performed with the weld repair report BWR-20769. The welding variables recorded by QC appeared to comply with the WPS-345-SMAW-4G(4F)-FCM-Repair-1. Please see the attached picture.
