Contract #: 04-0120F4Cty: SF/ALA Rte: 80 PM: 13.2/13.9File #: 99.28**WELDING INSPECTION REPORT****Resident Engineer:** Siegenthaler, Peter**Address:** 333 Burma Road**City:** Oakland, CA 94607**Report No:** WIR-023550**Date Inspected:** 08-May-2011**Project Name:** SAS Superstructure**OSM Arrival Time:** 700**Prime Contractor:** American Bridge/Fluor Enterprises, a JV**OSM Departure Time:** 1900**Contractor:** Zhenhua Port Machinery Company, Ltd (ZPMC) Chanxing Island**Location:** Shanghai, China**CWI Name:** Mr. LIU HUA JIE**CWI Present:** Yes No**Inspected CWI report:** Yes No N/A**Rod Oven in Use:** Yes No N/A**Electrode to specification:** Yes No N/A**Weld Procedures Followed:** Yes No N/A**Qualified Welders:** Yes No N/A**Verified Joint Fit-up:** Yes No N/A**Approved Drawings:** Yes No N/A**Approved WPS:** Yes No N/A**Delayed / Cancelled:** Yes No N/A**Bridge No:** 34-0006**Component:** OBG Segment**Summary of Items Observed:**

Orthotropic Box Girder (OBG) at Trial Assembly Area:

WELDING INSPECTION REPORT

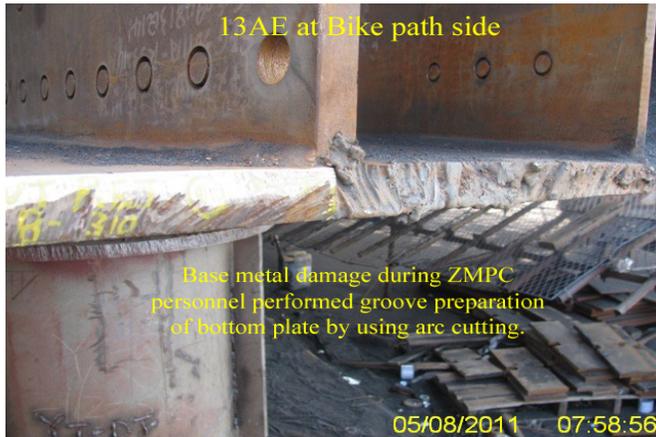
During the random visual inspection of welds located on Segment 13AE at bike path side, this Quality Assurance Inspector (QA) observed that base metal damage during ZMPC personnel performed groove preparation of bottom plate by using arc cutting. ZPMC QC is identified as Mr. WANG LI YANG. QA inform to ZPMC that prior to the repair welding, to prepare CWR and ensure with VT and MT all defect have been removed. See the attached picture.
