DEPARTMENT OF TRANSPORTATION

Contract #: 04-0120F4Cty: SF/ALA Rte: 80 PM: 13.2/13.9File #: 69.28**WELDING INSPECTION REPORT****Resident Engineer:** Siegenthaler, Peter**Address:** 333 Burma Road**City:** Oakland, CA 94607**Report No:** WIR-023580**Date Inspected:** 05-May-2011**Project Name:** SAS Superstructure**OSM Arrival Time:** 1500**Prime Contractor:** American Bridge/Fluor Enterprises, a JV**OSM Departure Time:** 300**Contractor:** Zhenhua Port Machinery Company, Ltd (ZPMC), Changxing Island **Location:** Shanghai, China**CWI Name:** See Below**CWI Present:** Yes No**Inspected CWI report:** Yes No N/A**Rod Oven in Use:** Yes No N/A**Electrode to specification:** Yes No N/A**Weld Procedures Followed:** Yes No N/A**Qualified Welders:** Yes No N/A**Verified Joint Fit-up:** Yes No N/A**Approved Drawings:** Yes No N/A**Approved WPS:** Yes No N/A**Delayed / Cancelled:** Yes No N/A**Bridge No:** 34-0006**Component:** OBG**Summary of Items Observed:**

WELDING INSPECTION REPORT

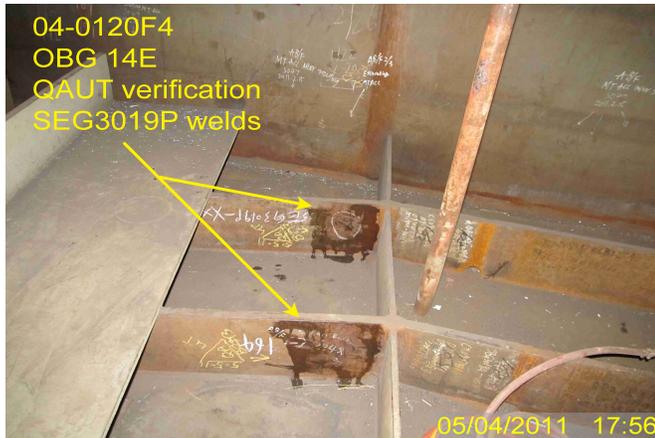
This Caltrans QA inspector received ZPMC non-destructive test (NDT) NWIT #09036 Item 1 for Trial Assembly OBG 14E. This QA Inspector performed verification Ultrasonic Testing (UT) inspection after ZPMC had performed their UT inspection of the following locations;

SEG3019P-159, 164, 169, 174, 219, 179, 184, 189, 194, 199, 204, 209, 214, 147, 153, 159, 165

The following digital picture illustrates QAUT inspection of typical welds.
