Contract #: 04-0120F4Cty: SF/ALA Rte: 80 PM: 13.2/13.9File #: 69.28**WELDING INSPECTION REPORT****Resident Engineer:** Siegenthaler, Peter**Address:** 333 Burma Road**City:** Oakland, CA 94607**Report No:** WIR-024450**Date Inspected:** 11-May-2011**Project Name:** SAS Superstructure**OSM Arrival Time:** 700**Prime Contractor:** American Bridge/Fluor Enterprises, a JV**OSM Departure Time:** 1900**Contractor:** Zhenhua Port Machinery Company, Ltd (ZPMC), Changxing Island **Location:** Shanghai, China**CWI Name:** Mr. Lu Hua Jie**CWI Present:** Yes No**Inspected CWI report:** Yes No N/A**Rod Oven in Use:** Yes No N/A**Electrode to specification:** Yes No N/A**Weld Procedures Followed:** Yes No N/A**Qualified Welders:** Yes No N/A**Verified Joint Fit-up:** Yes No N/A**Approved Drawings:** Yes No N/A**Approved WPS:** Yes No N/A**Delayed / Cancelled:** Yes No N/A**Bridge No:** 34-0006**Component:** Orthotropic Box Girder (OBG)**Summary of Items Observed:**

OBG Trial Assembly

WELDING INSPECTION REPORT

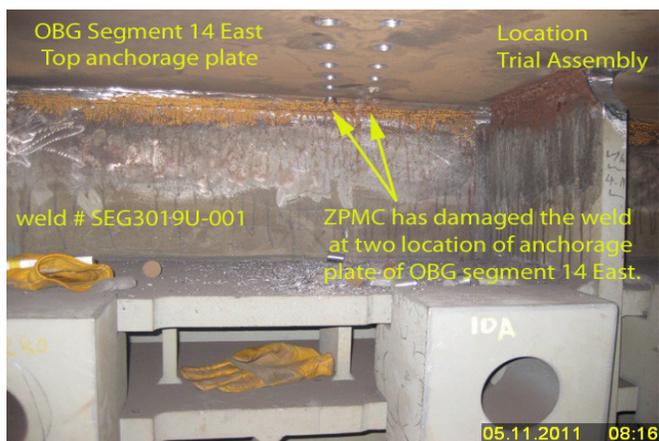
This QA Inspector observed ZPMC qualified welding personnel identified as 051356 Perform Flux Core Arc Welding (FCAW) on OBG Segment 14 East. Joint identified as SEG3019D-1-142. ZPMC QC Identified as Zhu Yuan Yuan. The welding parameters as measured using QC's calibrated instrument appeared to be in general compliance with WPS-B-T-2233-ESAB. For more information see below attached picture number 1.

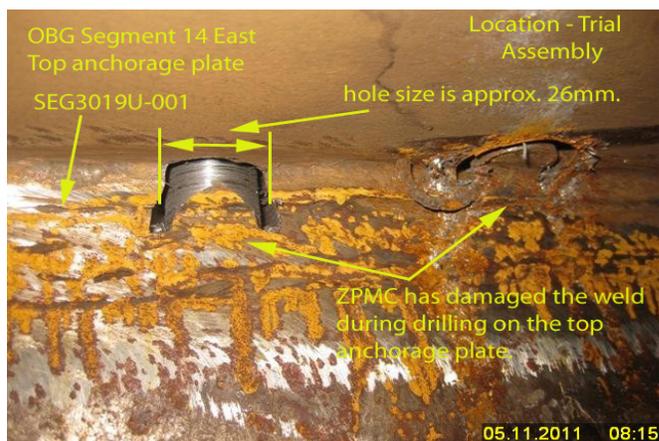
During Quality Assurance (QA) random visual inspection of OBG Segment 14 East Top anchorage plate, this

Caltrans QA Inspector observed the following issue: ZPMC personnel have miss-drilled a total of two (2) 30mm diameter bolt holes resulting in damage to the weld below. The holes were match drilled in the Top Anchorage Plate (AP3009A), and penetrate the Anchorage Plate web to the Top Anchorage Plate CJP (completed joint penetration) T-joint at panel point 126. The damaged weld is designated as SEG3019U-001. OBG Segment 14 East is located in Trial assembly. For further information, please see the attached pictures below This QA Inspector generated Incident report for this date.
