Quality Assurance and Source Inspection

Contract #: 04-0120F4Cty: SF/ALA Rte: 80 PM: 13.2/13.9File #: 69.28**WELDING INSPECTION REPORT****Resident Engineer:** Siegenthaler, Peter**Address:** 333 Burma Road**City:** Oakland, CA 94607**Report No:** WIR-024457**Date Inspected:** 19-May-2011**Project Name:** SAS Superstructure**OSM Arrival Time:** 700**Prime Contractor:** American Bridge/Fluor Enterprises, a JV**OSM Departure Time:** 1900**Contractor:** Zhenhua Port Machinery Company, Ltd (ZPMC), Changxing Island **Location:** Shanghai, China**CWI Name:** Mr. Lu Hua Jie**CWI Present:** Yes No**Inspected CWI report:** Yes No N/A**Rod Oven in Use:** Yes No N/A**Electrode to specification:** Yes No N/A**Weld Procedures Followed:** Yes No N/A**Qualified Welders:** Yes No N/A**Verified Joint Fit-up:** Yes No N/A**Approved Drawings:** Yes No N/A**Approved WPS:** Yes No N/A**Delayed / Cancelled:** Yes No N/A**Bridge No:** 34-0006**Component:** Orthotropic Box Girder (OBG)**Summary of Items Observed:**

OBG Trial Assembly

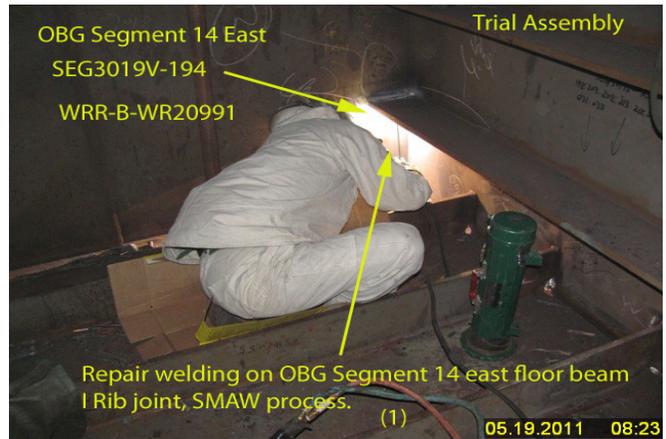
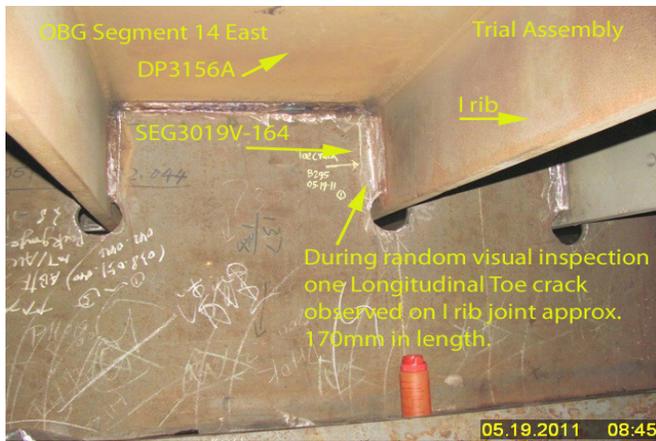
This QA Inspector performed randomly Visual Inspection in OBG Segment 14 East, panel point 125 at cross beam side of deck panel I rib joint. Joint identified as SEG3019V-164. The weld is fillet weld. One longitudinal Toe crack observed approximately 170 mm in length. For more information see below attached pictures.
