**DEPARTMENT OF TRANSPORTATION**

Contract #: 04-0120F4Cty: SF/ALA Rte: 80 PM: 13.2/13.9File #: 69.28**WELDING INSPECTION REPORT****Resident Engineer:** Siegenthaler, Peter**Address:** 333 Burma Road**City:** Oakland, CA 94607**Report No:** WIR-024854**Date Inspected:** 27-Jun-2011**Project Name:** SAS Superstructure**OSM Arrival Time:** 700**Prime Contractor:** American Bridge/Fluor Enterprises, a JV**OSM Departure Time:** 1900**Contractor:** Zhenhua Port Machinery Company, Ltd (ZPMC), Changxing Island **Location:** Shanghai, China**CWI Name:** Liu Hua Jie**CWI Present:** Yes No**Inspected CWI report:** Yes No N/A**Rod Oven in Use:** Yes No N/A**Electrode to specification:** Yes No N/A**Weld Procedures Followed:** Yes No N/A**Qualified Welders:** Yes No N/A**Verified Joint Fit-up:** Yes No N/A**Approved Drawings:** Yes No N/A**Approved WPS:** Yes No N/A**Delayed / Cancelled:** Yes No N/A**Bridge No:** 34-0006**Component:** OBG**Summary of Items Observed:**

# WELDING INSPECTION REPORT

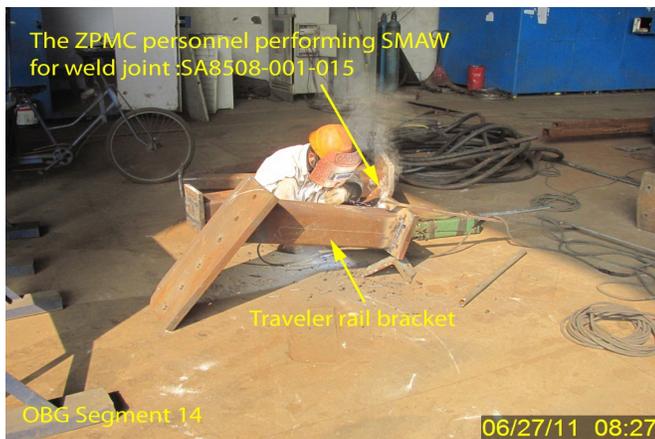
SMAW in the 3G position for the OBG Segment 14W&14E Traveler rail bracket. The weld joint was designated as: SA8508-001-015. The welder is identified as #051359. ZPMC CWI is identified as Mr. Liu Hua Jie. The welding variables recorded by QC appear to comply with WPS-B-P-2213-TC-U4C. Please see the attached picture.
