DEPARTMENT OF TRANSPORTATION

Contract #: 04-0120F4Cty: SF/Ala Rte: 80 PM: 13.2/13.9File #: 69.28**WELDING INSPECTION REPORT****Resident Engineer:** Siegenthaler, Peter**Address:** 333 Burma Road**City:** Oakland, CA 94607**Report No:** WIR-025180**Date Inspected:** 24-Jun-2011**Project Name:** SAS Superstructure**OSM Arrival Time:** 1900**Prime Contractor:** American Bridge/Fluor Enterprises, a JV**OSM Departure Time:** 700**Contractor:** Zhenhua Port Machinery Company, Ltd (ZPMC), Changxing Island **Location:** Shanghai, China

WELDING INSPECTION REPORT

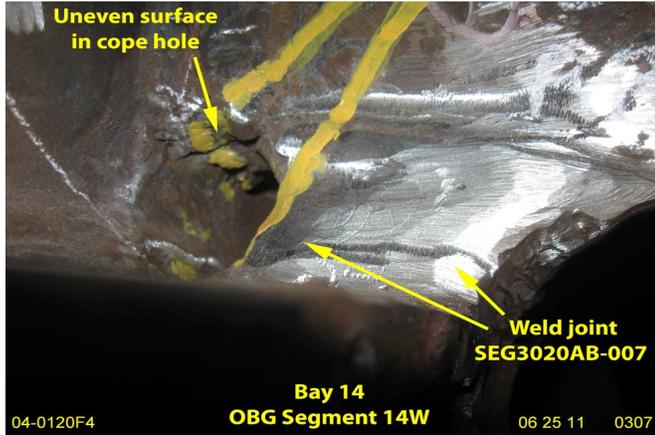
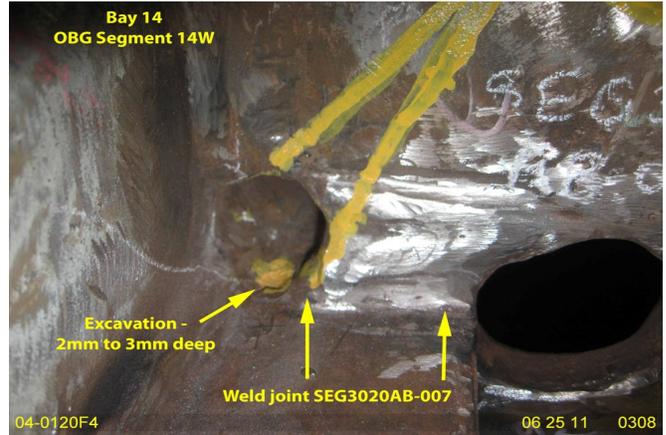
OBG Segment 14W, SEG3020AB. The weld designations reviewed were: 001, 002, 003, 005, 006, 008. No apparent indications were observed. Weld joint SEG3020AB-007 was also listed on NWIT #9602 and accepted by ABF inspectors. However, weld joint SEG3020AB-007 was rejected by this QA Inspector due to VT indications including uneven surface area and an approximate 10mm x 15mm excavation, 2mm to 3mm deep in the cope hole area. See photos below showing the indications observed by this QA Inspector.

weld joint SEG3020K-020 was rejected by this QA Inspector due to VT indications observed by this QA Inspector.
