DEPARTMENT OF TRANSPORTATION

Quality Assurance and Source Inspection

Contract #: 04-0120F4Cty: SF/ALA Rte: 80 PM: 13.2/13.9File #: 69.28**WELDING INSPECTION REPORT****Resident Engineer:** Siegenthaler, Peter**Address:** 333 Burma Road**City:** Oakland, CA 94607**Report No:** WIR-025747**Date Inspected:** 29-Jun-2011**Project Name:** SAS Superstructure**OSM Arrival Time:** 1500**Prime Contractor:** American Bridge/Fluor Enterprises, a JV**OSM Departure Time:** 300**Contractor:** Zhenhua Port Machinery Company, Ltd (ZPMC), Changxing Island **Location:** ShangHai, China**CWI Name:** Shi Yu**CWI Present:** Yes No**Inspected CWI report:** Yes No N/A**Rod Oven in Use:** Yes No N/A**Electrode to specification:** Yes No N/A**Weld Procedures Followed:** Yes No N/A**Qualified Welders:** Yes No N/A**Verified Joint Fit-up:** Yes No N/A**Approved Drawings:** Yes No N/A**Approved WPS:** Yes No N/A**Delayed / Cancelled:** Yes No N/A**Bridge No:** 34-0006**Component:** OBG**Summary of Items Observed:**

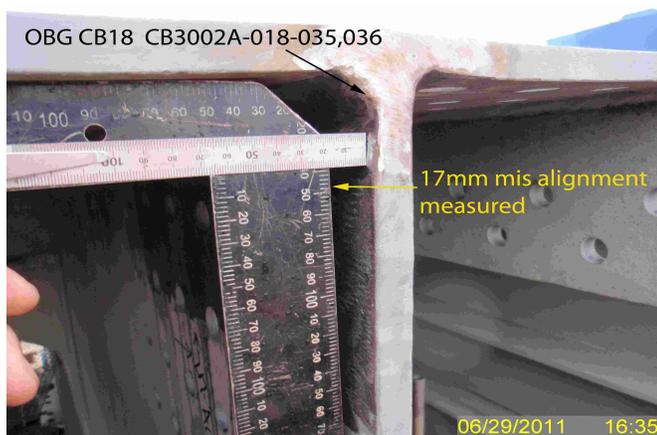
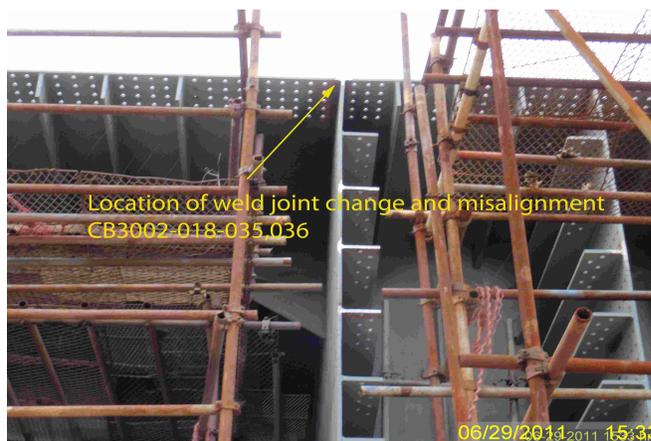
During Quality Assurance (QA) random in-process observations of the fabrication of OBG CB3002A-018, Weld ID number is CB3002A-018-035,-036, this Caltrans QA Inspector observed the following issues:

-ZPMC has changed a joint design without prior approval from the Engineer.

-According to approved shop drawing, the joint is designed for 6mm fillet.

- The joint has been changed to a Complete Joint Penetration (CJP).
- ZPMC has completed the repair welding without an approved critical weld repair (CWR) procedure.
- The length of welding was measured to be 350mm for the hold back location.
- The affected members are identified as CB3002A-018-035,036
- Due to ZPMC performing the weld repair the component is approximately 17mm misalignment.
