Contract #: 04-0120F4Cty: SF/ALA Rte: 80 PM: 13.2/13.9File #: 69.28**WELDING INSPECTION REPORT****Resident Engineer:** Siegenthaler, Peter**Address:** 333 Burma Road**City:** Oakland, CA 94607**Report No:** WIR-026915**Date Inspected:** 19-Aug-2011**Project Name:** SAS Superstructure**OSM Arrival Time:** 700**Prime Contractor:** American Bridge/Fluor Enterprises, a JV**OSM Departure Time:** 1900**Contractor:** Zhenhua Port Machinery Company, Ltd (ZPMC), Changxing Island **Location:** Shanghai, China**CWI Name:** Shigang/Jun**CWI Present:** Yes No**Inspected CWI report:** Yes No N/A**Rod Oven in Use:** Yes No N/A**Electrode to specification:** Yes No N/A**Weld Procedures Followed:** Yes No N/A**Qualified Welders:** Yes No N/A**Verified Joint Fit-up:** Yes No N/A**Approved Drawings:** Yes No N/A**Approved WPS:** Yes No N/A**Delayed / Cancelled:** Yes No N/A**Bridge No:** 34-0006**Component:** OBG Bike Path**Summary of Items Observed:**

# WELDING INSPECTION REPORT

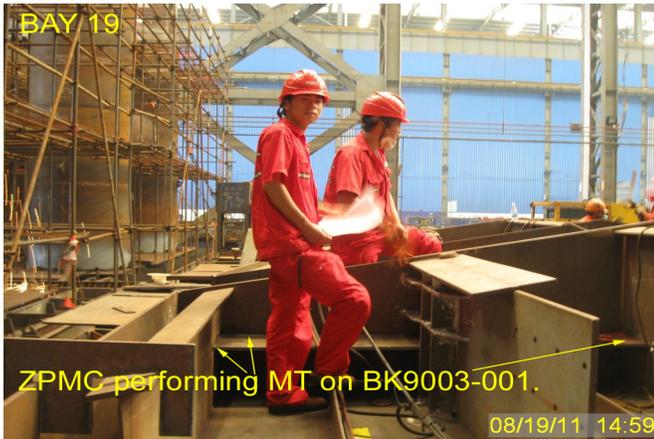
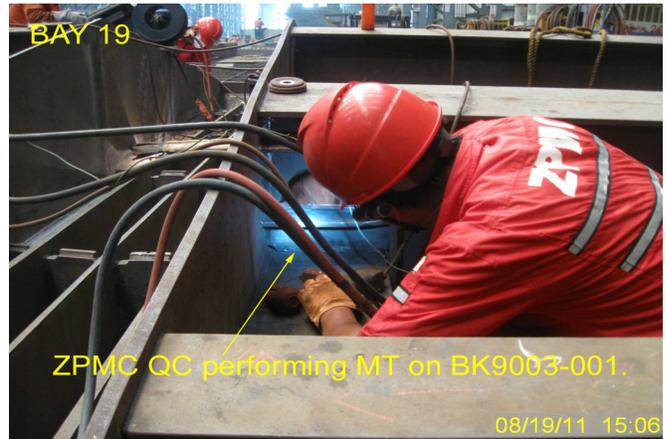
This QA Inspector observed at random intervals, ZPMC personnel performing grinding of welds on Bike Path BK9003A8-001 for OBG Bike Path. It appears that ZPMC is performing contour grinding of finished welds.

This QA Inspector observed ZPMC personnel performing MT on OBG Bike Path welds located on BK9003A9-001. ZPMC Quality Control (QC) is identified as Peng Wen Jun.

Unless otherwise noted, all work observed on this date appeared to generally comply with applicable contract documents.
