Contract #: 04-0120F4Cty: SF/ALA Rte: 80 PM: 13.2/13.9File #: 69.25B**QUALITY ASSURANCE -- NON-CONFORMANCE REPORT****Location:** Changxing Island, Shanghai, P.R. China**Report No:** NCR-000235**Prime Contractor:** American Bridge/Fluor Enterprises, a JV**Date:** 28-Mar-2009**Submitting Contractor:** Zhenhua Port Machinery Company, Ltd (ZPMC), Changxing Island**NCR #:** ZPMC-0209**Type of problem:**

**Job Name:** SAS Superstructure

**Subject:** NCR No. ZPMC-0209

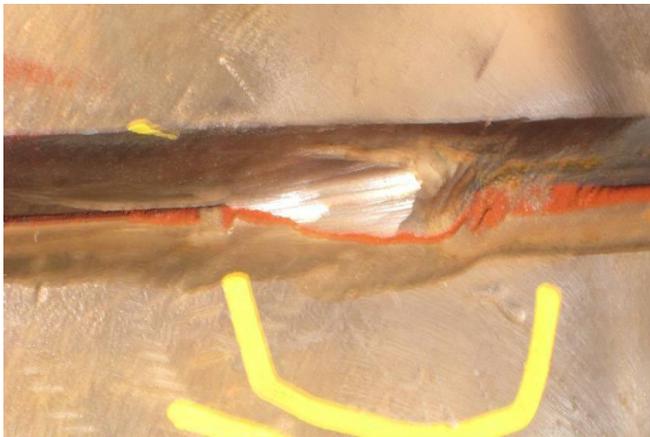
Caltrans Quality Assurance (QA) Inspector performed Magnetic Particle Testing (MT) of tack welds connecting side panels for segment 3AW to 3BW, weld joints OBW-3A-002 and OBW-3A-004. The MT result showed multiple linear indications that were found acceptable by ZPMC MT Technicians previously.

AWS D1.5 (2002) – Sec. 6.26.2 - "Welds that are subject to MT in addition to visual inspection shall have no cracks."

The proposed resolution is acceptable. The welds in question have been accepted by VT, MT, and UT as shown in the attached documents. The Department concurs that Non-Conformance ZPMC-0209 is closed.

ZPMC QC inspectors to receive training training in regards to performing MT inspections in conformance with Section 6.26.2 of AWS D1.5. Frequency of MT inspections to be increased.

ZPMC QC inspectors to received training training in regards to performing MT inspections in conformance with Section 6.26.2 of AWS D1.5. Frequency of MT inspections was increased. The welds in question were repaired and accepted.
