QUALITY ASSURANCE -- NON-CONFORMANCE REPORT

Location: Changxing Island, Shanghai, P.R. China**Report No:** NCR-000770**Prime Contractor:** American Bridge/Fluor Enterprises, a JV**Date:** 20-Jun-2010**Submitting Contractor:** Zhenhua Port Machinery Company, Ltd (ZPMC), Changxing Island**NCR #:** ZPMC-0732**Type of problem:**

Reference Description: QA found a 75mm long "class A" UT rejectable indication in a Suspender Bracket at PP70

Component: Suspender Bracket for Segment 8CW

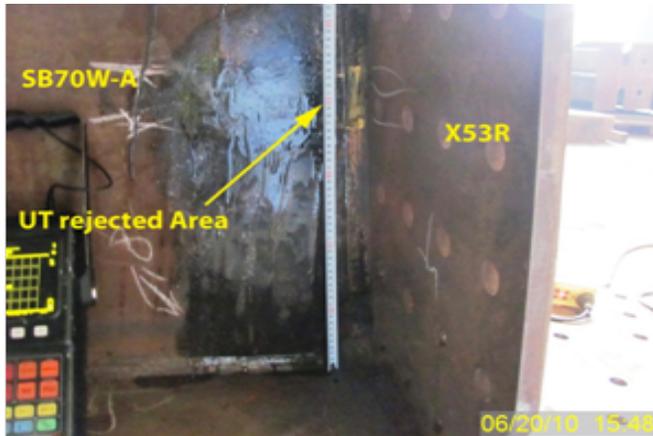
During the Quality Assurance (QA) Ultrasonic Testing (UT) review of welds located on Orthotropic Box Girder (OBG) Suspender Bracket SB70W (Segment 8CW), this QA Inspector discovered the following issues:

- One class "A" UT rejectable longitudinal linear indication measuring approximately 75mm in length.
- The indication dBs rating is a +4.
- Material thickness is 35mm.
- The depth of the indication is approximately 28mm.
- The weld is identified as SB016-070-005.
- The weld is a Complete Joint Penetration (CJP) "T" joint joining the Edge Plate X53R to Web Plate SB70W-A.
- The indication is clearly marked on or near the weld.
- The Y distance for this indication is 365 mm from bottom cope hole.
- Suspender Bracket SB70W is located at Bay#19.
- The Notice of Witness Inspection (NWIT) No. is 006019. The indication is located within the area previously tested and accepted by ZPMC Quality Control (QC) personnel. As per the contract documents, ZPMC's QC personnel are required to perform 100% UT inspection of this weld.

AWS D1.5-02 Section 6: Table 6.3 specifies a class “A” indication as having a rating of 8dbs and under for material thicknesses 21mm through 38mm.

Reference Resolution: ZPMC has performed the repair of this indication and attached the subsequent UT report denoting acceptance of this weld.

Repair said indication and perform NDT required to verify weld quality.

Contractor supplied post repair NDT documentation verifying repair meets Contract weld quality requirements. ZPMC has instituted disciplinary actions as well as incentives to prompt inspectors to perform more thorough inspections.

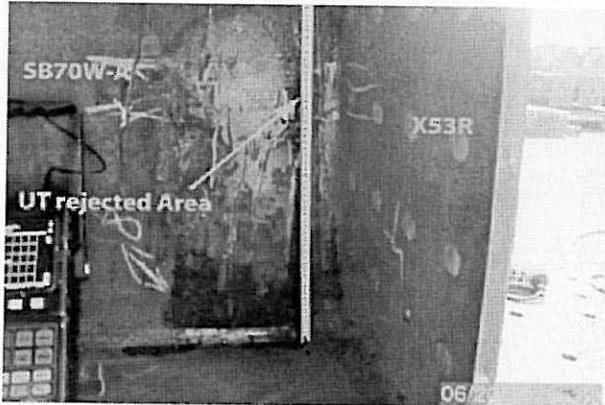
- During the Quality Assurance (QA) Ultrasonic Testing (UT) review of welds located on Orthotropic Box Girder (OBG) Suspender Bracket SB70W (Segment 8CW), this QA Inspector discovered the following issues:

- One class "A" UT rejectable longitudinal linear indication measuring approximately 75mm in length.
 - The indication dBs rating is a +4.
 - Material thickness is 35mm.

- The depth of the indication is approximately 28mm.
 - The weld is identified as SB016-070-005.
 - The weld is a Complete Joint Penetration (CJP) "T" joint joining the Edge Plate X53R to Web Plate SB70W-A.

- The indication is clearly marked on or near the weld.
 - The Y distance for this indication is 365 mm from bottom cope hole.
 - Suspender Bracket SB70W is located at Bay#19.

- The Notice of Witness Inspection (NWIT) No. is 006019. The indication is located within the area previously tested and accepted by ZPMC Quality Control (QC) personnel. As per the contract documents, ZPMC's QC personnel are required to perform 100% UT inspection of this weld.

AWS D1.5-02 Section 6: Table 6.3 specifies a class "A" indication as having a rating of 8dbs and under for material thicknesses 21mm through 38mm.
