Contract #: 04-0120F4Cty: SF/ALA Rte: 80 PM: 13.2/13.9File #: 69.25B**QUALITY ASSURANCE -- NON-CONFORMANCE REPORT****Location:** Changxing Island, Shanghai, P.R. China**Report No:** NCR-000856**Prime Contractor:** American Bridge/Fluor Enterprises, a JV**Date:** 04-Oct-2010**Submitting Contractor:** Zhenhua Port Machinery Company, Ltd (ZPMC), Changxing Island**NCR #:** ZPMC-0818**Type of problem:**

Reference Description: Fit Lug Removal without Engineer's approval located at West Shaft (109m) and South Shaft (119m)

Job Name: SAS Superstructure
Document No: 05.03.06-000813

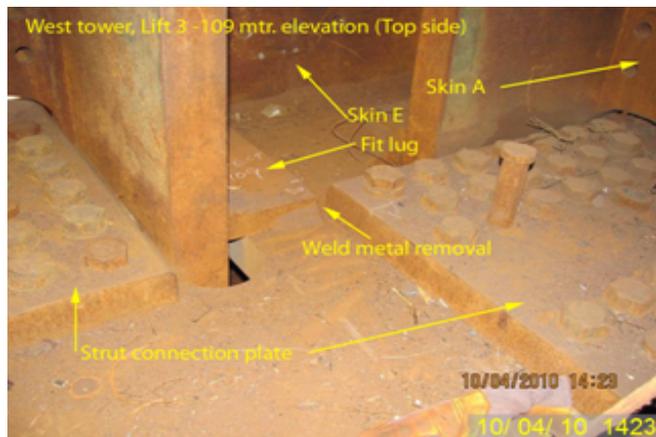
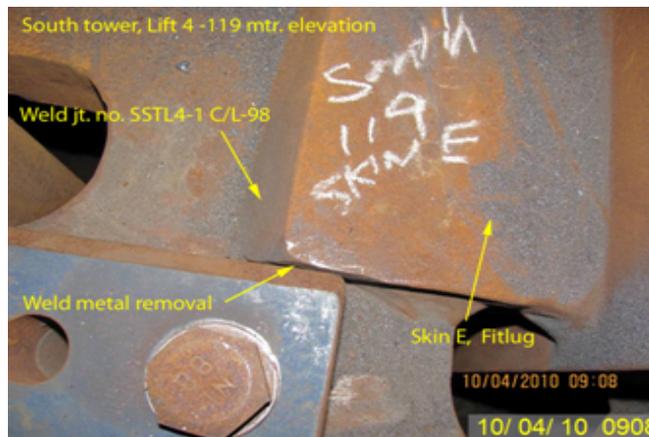
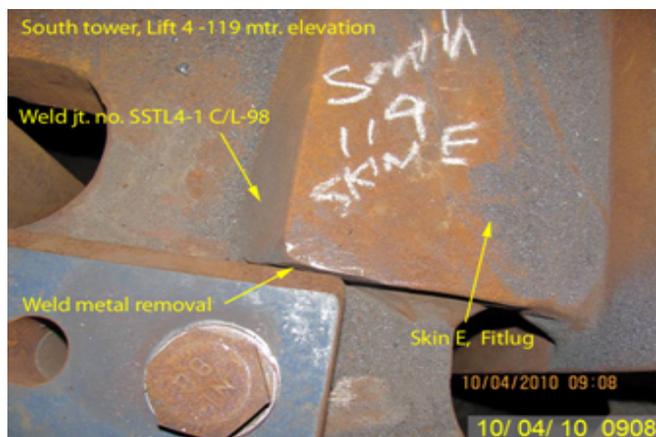
- Approx. 50mm length, weld metal removal observed in Skin E, fit lug weld, without Engineer's approval.
- The fit lug found in West Tower, Lift 3- 109m top diaphragm.
- The weld joint no. of the fit lug weld found to be WSTL3-4 I / K-128.

- Approx. 55mm length, weld metal removal observed in Skin E, fit lug weld, without Engineer's approval.
- The fit lug found in South Tower, Lift 4- 119m top diaphragm.
- The weld joint no. of the fit lug weld found to be SSTL4-1 C/L-98.

Reference Resolution: ZPMC has resolved the issue of the cut fit lug, and is providing NDT at one location (WSTL3-4I/K-128) where the fit lug was cut and grinded.

ZPMC has resolved the issue of the cut fit lug, and is providing NDT at one location (WSTL3-4I/K-128) where the fit lug was cut and grinded. Magnetic particle testing was done on the grinded area to show that the grinded surface was free of defect. The second location in lift 4 will be grinded and tested when it is accessible. ZPMC requests that since the condition in Lift 3 has been repaired that this NCR be approved with action pending until Lift 4 is accessible again.
