Contract #: 04-0120F4Cty: SF/ALA Rte: 80 PM: 13.2/13.9File #: 69.25B**QUALITY ASSURANCE -- NON-CONFORMANCE REPORT****Location:** Changxing Island, Shanghai, China**Report No:** NCR-000906**Prime Contractor:** American Bridge/Fluor Enterprises, a JV**Date:** 24-Nov-2010**Submitting Contractor:** Zhenhua Port Machinery Company, Ltd (ZPMC), Changxing Island**NCR #:** ZPMC-0868**Type of problem:**

Welding	Concrete	Other	
Welding	Curing	Procedural	Bridge No: 34-0006
Joint fit-up	Coating	Other	Component: Crossbeam 19, CB3003A-019
Procedural	Procedural	Description:

Reference Description: New Welding Procedure Not Followed (Rager/McQuaid)**Description of Non-Conformance:**

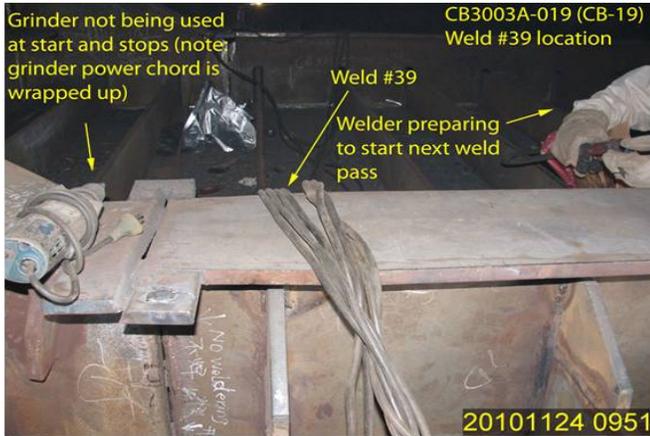
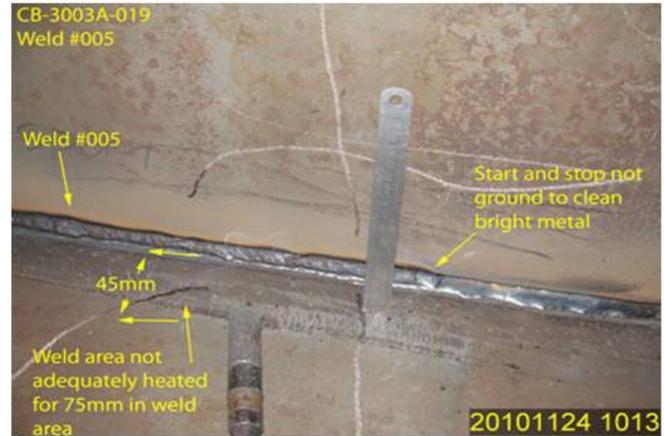
During Caltrans QA in process observations of the fabrication of CB3003A-019 (Crossbeam CB19) this QA discovered the following issue(s):

ZPMC welding personnel did not appear to be following the NEW WELD PROCEDURE (Rager/McQuaid)

3. Preparation for welding (3M)
4. Welding (4A, 4C, 4D, 4E)

The welds are identified as follows: CB3003A-019-005, CB3003A-019-017, DP3179-001-039

The area was being preheated using electric strip heater on weld CB3003-019-005.

The weld is a complete joint penetration weld joining stiffener to stiffener, side plate to deck plate and side plate to top plate.

Reference attached photos below:

Reference Resolution: ZPMC is providing NDT to show the welds are acceptable.

ZPMC is providing NDT to show the welds are acceptable. The weld identified as DP3179-001-039, was misidentified and should be DP 3179-1-001-039. Based on the acceptable NDT, ZPMC requests closure of this NCR.

Contractor provided the NDT report to prove the weld is acceptable. The Weld referenced ID DP3179-001-039 should actually be DP 3179-1-001-039.
