Contract #: 04-0120F4Cty: SF/ALA Rte: 80 PM: 13.2/13.9File #: 69.25B

QUALITY ASSURANCE -- NON-CONFORMANCE REPORT

Location: Changxing Island, Shanghai, China**Report No:** NCR-000909**Prime Contractor:** American Bridge/Fluor Enterprises, a JV**Date:** 24-Nov-2010**Submitting Contractor:** Zhenhua Port Machinery Company, Ltd (ZPMC), Changxing Island**NCR #:** ZPMC-0871**Type of problem:****Welding****Concrete****Other****Welding****Curing****Procedural****Bridge No:** 34-0006**Joint fit-up****Coating****Other****Component:** Lift 14E, SEG3019AY-009**Procedural****Procedural****Description:****Reference Description:** New Weld Procedure Not Followed (Rager/McQuaid)**Description of Non-Conformance:**

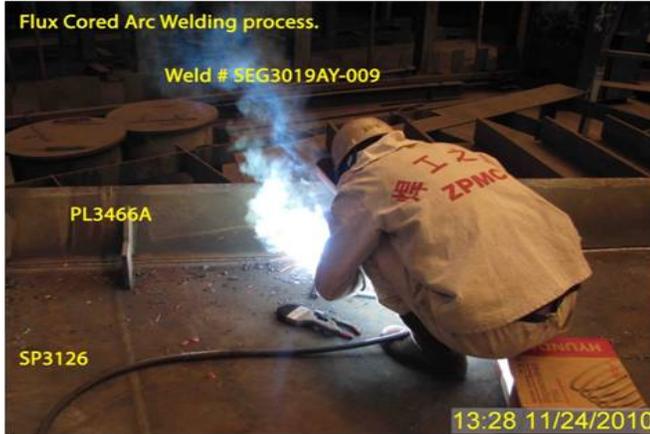
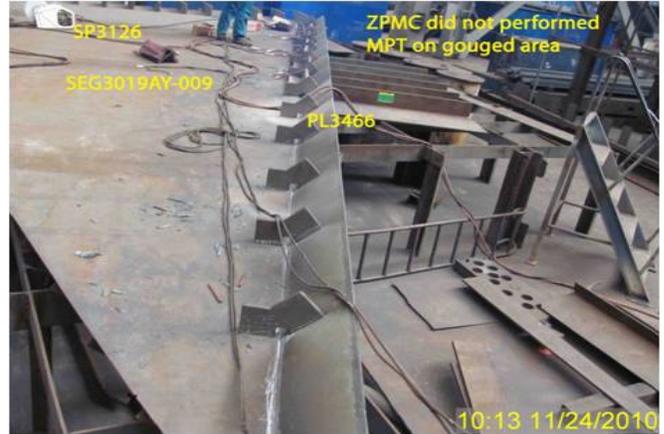
- ZPMC personnel performed welding for the weld between SP3126A (PL3462A) and plate (PL3466A) without performing NDT (Magnetic Particle testing) on the gouged area.
- Weld number identified as SEG3019AY-009
- Weld details as complete joint penetration(CJP)
- PL3462 designated on the approved shop drawings as Seismic Performance Critical Members (SPCM).
- The welding performed with Flux Cored Arc Welding (FCAW) process.
- OBG lift 14 East located in Bay # 14

See attached photographs for additional detail.

6) Non destructive testing: A. All back gouged groove welds are to have their gouged areas ground to bright metal and inspected 100% by VT and MT examination before welding may begin from the second side.

Contractor will provide the NDT report to prove the weld is acceptable.

Contractor provided the NDT report to prove the weld is acceptable. The Weld ID SEG3019AY-009 referenced in the NCR has been changed to SEG3019AY-006.
