Contract #: 04-0120F4  
 Cty: SF/ALA Rte: 80 PM: 13.2/13.9  
 File #: 69.25B

**QUALITY ASSURANCE -- NON-CONFORMANCE REPORT**

**Report No:** NCR-000294

**Reference Description:** Excessive Splice Plate to U-Rib Offset, Segment Splice 4AE/4BE

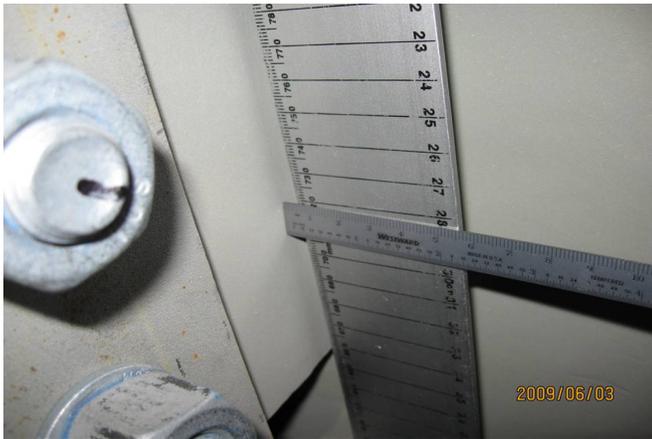
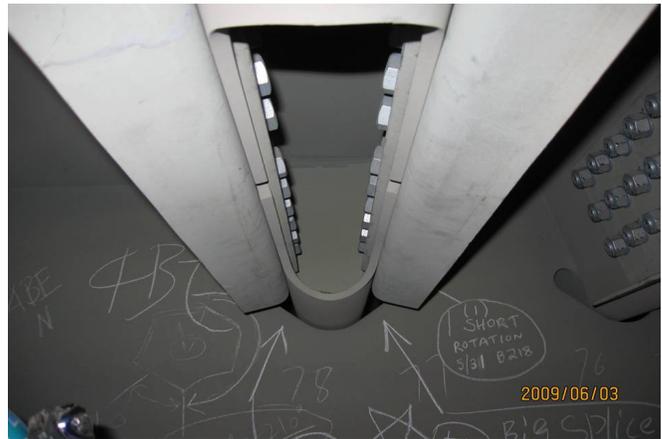
Caltrans Quality Assurance (QA) Inspector observed that ZPMC had installed the U-rib splice plates connecting Segments 4AE to 4BE. Random measurements were taken by the QA Inspector and offsets between the splice plates and U-Ribs were observed that exceed the approved dimensional tolerances. No shim plates were installed to correct the offsets.

Rib #	Offset (Left Side)	Offset (Right Side)
1	-3mm	+5mm
2	---	+3mm
4	+4mm	---
23	-3mm	---

Special Provision – Shop Welding - Design Details - Item No. 1.e - Page 323 – “Ribs shall align within 4mm and surfaces to be in contact shall have an offset no greater than 2mm after shimming.”

Contractor has acknowledged that this item must be addressed, and the item was added to the Master Punchlist.

Work was completed and item was cleared on Master Punchlist by Caltrans on 8-1-09. Submittal of documentation by Contractor being tracked on Documentation Punchlist.
