Contract #: 04-0120F4Cty: SF/ALA Rte: 80 PM: 13.2/13.9File #: 69.25B

QUALITY ASSURANCE -- NON-CONFORMANCE REPORT

Reference Description: New Welding Procedure Not Being Followed**Description of Non-Conformance:**

Job Name: SAS Superstructure
Document No: 05.03.06-000876

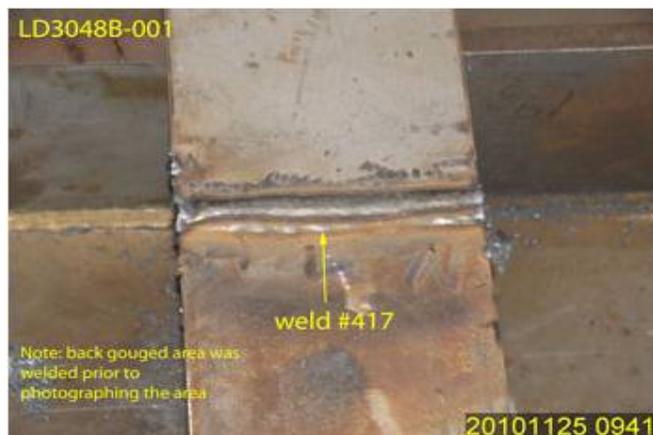
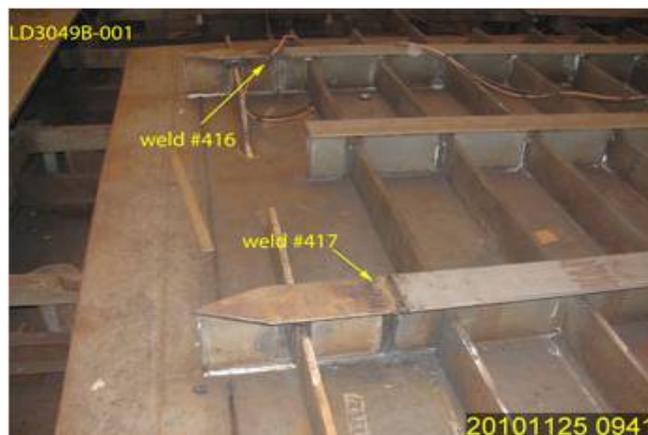
During Caltrans QA in process observations of the fabrication of LD3049B-001, this QA discovered the following issue(s): ZPMC welding personnel did not appear to be following the NEW WELD PROCEDURE (Rager / McQuaid)

6. Non Destructive testing (6A)

The weld is identified as LD3049B-001-416 & 417

The welding process used was FCAW

The weld is a complete joint penetration joining X4965B to X4965B (stiffener splice)

Reference additional details in the pics attached below.

Propose a resolution for the identified non-conformance with revised procedures to prevent future occurrences. A response for the resolution of this issue is expected within 7 days.

CT acknowledges contractor's response. However, successful NDT will close this NCR.

This proposed resolution is acceptable. The documentation received is sufficient and the Department concurs that Non-Conformance ZPMC-0881 is closed.

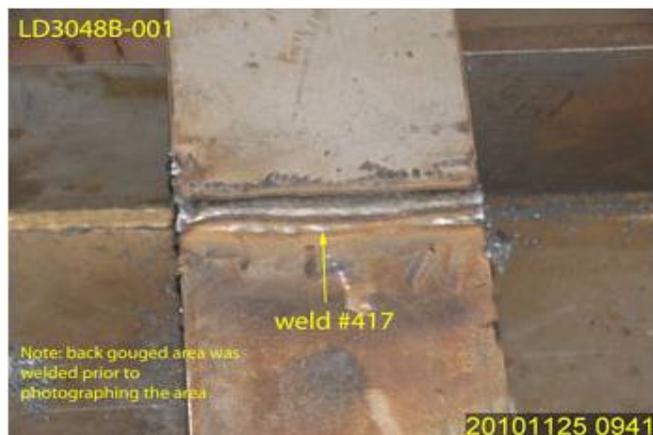
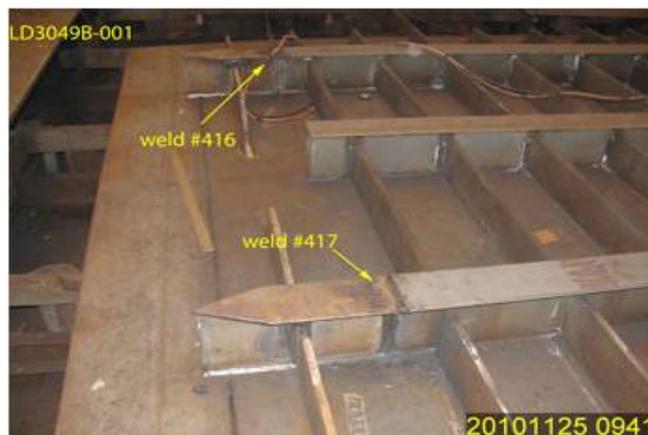
During Caltrans QA in process observations of the fabrication of LD3049B-001, this QA discovered the following issue(s): ZPMC welding personnel did not appear to be following the NEW WELD PROCEDURE (Rager / McQuaid)

6. Non Destructive testing (6A)

The weld is identified as LD3049B-001-416 & 417

The welding process used was FCAW

The weld is a complete joint penetration joining X4965B to X4965B (stiffener splice)

Reference additional details in the pics attached below.

Contractor will provide the NDT report to prove the weld is acceptable.

Contractor provided the NDT report. The NDT report proves the weld is acceptable.
