Contract #: 04-0120F4Cty: SF/ALA Rte: 80 PM: 13.9/14.3,0.0/1.6File #: 69.28**WELDING INSPECTION REPORT****Resident Engineer:** Pursell, Gary**Address:** 333 Burma Road**City:** Oakland, CA 94607**Report No:** WIR-000821**Date Inspected:** 06-Nov-2007**Project Name:** SAS Superstructure**OSM Arrival Time:** 600**Prime Contractor:** American Bridge/Fluor Enterprises, a JV**OSM Departure Time:** 1530**Contractor:** Zhenhua Port Machinery Company, Ltd (ZPMC), Changxing Island **Location:** Shanghai, China**CWI Name:** Ye Yong Jun, Li Gang**CWI Present:** Yes No**Inspected CWI report:** Yes No N/A**Rod Oven in Use:** Yes No N/A**Electrode to specification:** Yes No N/A**Weld Procedures Followed:** Yes No N/A**Qualified Welders:** Yes No N/A**Verified Joint Fit-up:** Yes No N/A**Approved Drawings:** Yes No N/A**Approved WPS:** Yes No N/A**Delayed / Cancelled:** Yes No N/A**Bridge No:** 34-0006**Component:** CalTrans mock up**Summary of Items Observed:**

Caltrans Quality Assurance (QA) Inspector, Dan Hernandez was present to observe the fitup, welding and related activities associated with the fabricating of Caltrans Mock-ups 89.00 for the San Francisco Oakland Bay Self Anchored Suspensi

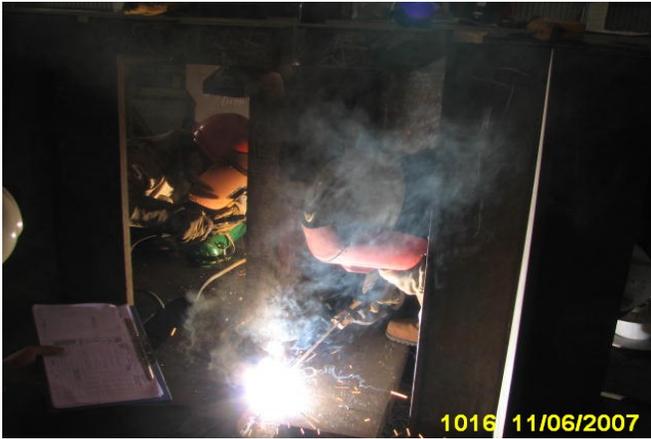
Item Description	WBS	Dwg No.	Status
1 89M Diaphragm			In Progress

Caltrans QA Inspector observed Shielded Metal Arc Welding (SMAW) in progress of fill passes on diaphragm web plate p138 to diaphragm plate p213. The weld joint is a Partial Joint Penetration (PJP) double bevel T-joint in the 2G position. The approved welders Xu Wei #066253 and Liu Guo Xuan #066279 were using approved welding procedure specification WPS-B-T-3312-TC-P5. Caltrans QA Inspector measured current welding parameters at approximately 243 amps, 22.5 volts and 152 millimeters per minute (mm/min) travel speed. Preheat and interpass temperatures were verified during welding activities. The preheat temperature prior to the start of welding measures more than 110 Celsius (230 degree Fahrenheit) but less than 232 Celsius (450 degrees Fahrenheit) during maximum interpass temperature verification. SMAW welding consumable is verified and identified as classification E9018 H4R Excalibur 4mm diameter. An electrode oven was observed by Caltrans QA Inspector in use during the welding process. ZPMC Quality Control (QC) Certified Welding Inspector (CWI) Mr. Ye Yong Jun and Bureau Veritas Inspector Mr. Li Gang were observed monitoring welding activities at the work station.

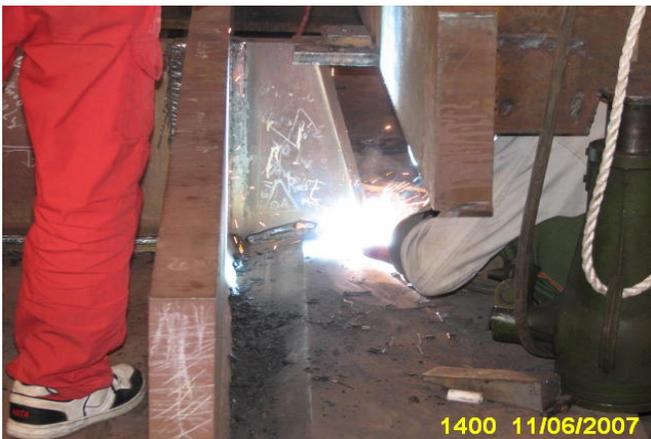
2 89M Intermediate Stiffener plates

Caltrans QA Inspector observed Flux Cored Arc Welding (FCAW) in progress of fill passes on intermediate stiffener plate A118 to longitudinal stiffener mp531-1. The weld joint is a Partial Joint Penetration (PJP) double bevel T-joint in the 3G position. The approved welder Li Shuoqiang #053609 was using approved welding procedure specification WPS-B-T-2233-TC-P4-F. Caltrans QA Inspector measured current welding parameters at approximately 205 amps, 27 volts and 116 millimeters per minute (mm/min) travel speed. Preheat and interpass temperatures were verified during welding activities. The preheat temperature prior to the start of welding measures more than 110 Celsius (230 degree Fahrenheit) but less than 232 Celsius (450 degrees Fahrenheit) during maximum interpass temperature verification. FCAW welding consumable is verified and identified as Supercored 71H, classification E71T-1, diameter 1.4 mm (.055 inches). ZPMC Quality Control (QC) Certified Welding Inspector (CWI) Mr. Xu Lefeng and Bureau Veritas Inspector Mr. Zhang Xu Liang were observed monitoring welding activities at the work station.
