**DEPARTMENT OF TRANSPORTATION**

Contract #: 04-0120F4Cty: SF/ALA Rte: 80 PM: 13.9/14.3,0.0/1.6File #: 69.28**WELDING INSPECTION REPORT****Resident Engineer:** Pursell, Gary**Address:** 333 Burma Road**City:** Oakland, CA 94607**Report No:** WIR-000832**Date Inspected:** 13-Nov-2007**Project Name:** SAS Superstructure**OSM Arrival Time:** 2300**Prime Contractor:** American Bridge/Fluor Enterprises, a JV**OSM Departure Time:** 730**Contractor:** Zhenhua Port Machinery Company, Ltd (ZPMC), Changxing Island **Location:** Shanghai, China**CWI Name:** Xu Lefeng**CWI Present:** Yes No**Inspected CWI report:** Yes No N/A**Rod Oven in Use:** Yes No N/A**Electrode to specification:** Yes No N/A**Weld Procedures Followed:** Yes No N/A**Qualified Welders:** Yes No N/A**Verified Joint Fit-up:** Yes No N/A**Approved Drawings:** Yes No N/A**Approved WPS:** Yes No N/A**Delayed / Cancelled:** Yes No N/A**Bridge No:** 34-0006**Component:** Caltrans Mock-Up**Summary of Items Observed:**

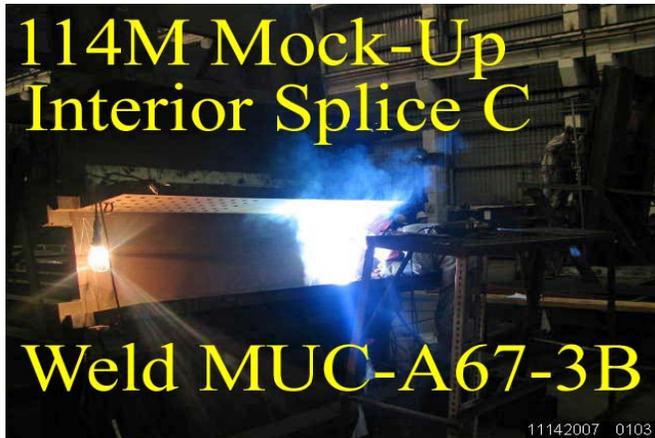
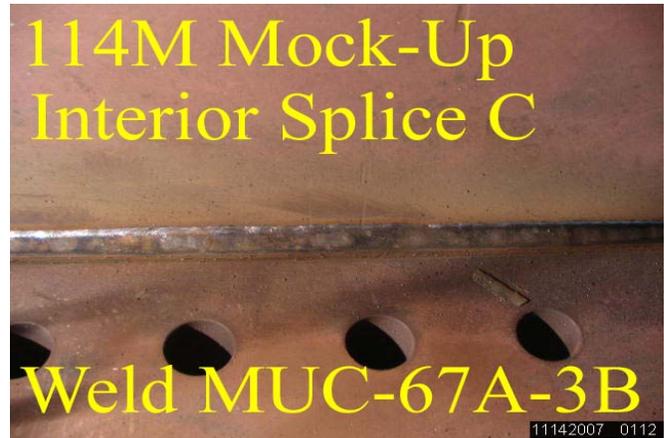
Caltrans QA Inspector observed the welding of p290-8 stiffener to A67 skin plate for the 114M Mock-Up Interior Splice Assembly, Skin Plate C. This weld is identified as MUC-A67-3B. Welding Procedure Specification (WPS) B-T-2231-TC-U5-F, Revision 1, for Flux Cored Arc Welding (FCAW) was being used. The welder was Bai Wenming (Welder I.D. No. 040434). ZPMC American Welding Society (AWS) Certified Welding Inspector (CWI), Xu Lefeng (CWI No. 07031411) and Bureau Veritas Inspector, Li Gang were present during this welding. The QA Inspector verified compliance with the WPS in the following areas using visual observation, calibrated Fluke ampmeter, Tempil stick, tape measure and stop watch, as applicable.

The QA Inspector also observed that the QC Inspector was documenting the parameters as welding progressed and that the random verification by the QA Inspector essentially confirmed the QC documentation for the random sample, and that QC documentation showed compliance with the WPS up to the time of the random sample. This weld was not completed during this shift.
