DEPARTMENT OF TRANSPORTATION

Contract #: 04-0120F4Cty: SF/ALA Rte: 80 PM: 13.9/14.3,0.0/1.6File #: 69.28**WELDING INSPECTION REPORT****Resident Engineer:** Pursell, Gary**Address:** 333 Burma Road**City:** Oakland, CA 94607**Report No:** WIR-000844**Date Inspected:** 11-Nov-2007**Project Name:** SAS Superstructure**OSM Arrival Time:** 630**Prime Contractor:** American Bridge/Fluor Enterprises, a JV**OSM Departure Time:** 1530**Contractor:** Zhenhua Port Machinery Company, Ltd (ZPMC), Changxing Island **Location:** Changxing Island**CWI Name:** Fu Guo Gan**CWI Present:** Yes No**Inspected CWI report:** Yes No N/A**Rod Oven in Use:** Yes No N/A**Electrode to specification:** Yes No N/A**Weld Procedures Followed:** Yes No N/A**Qualified Welders:** Yes No N/A**Verified Joint Fit-up:** Yes No N/A**Approved Drawings:** Yes No N/A**Approved WPS:** Yes No N/A**Delayed / Cancelled:** Yes No N/A**Bridge No:** 34-0006**Component:** Mock-up # 114**Summary of Items Observed:**

Caltrans Quality Assurance (QA) Inspector, Larry Viars was present to observe the Welding and Magnetic Particle Testing (MT) of the Caltrans Mock-up # 114.00, for the San Francisco Oakland Bay Self Anchored Suspension B

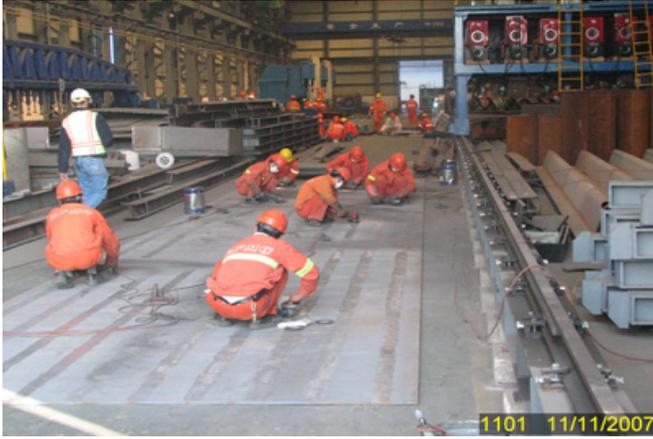
Caltrans QA Inspector Viars observed ZPMC personnel prepping Orthotropic Box Girder Closed rib weld trial # 3 deck plate for welding. The attached photo below shows ZPMC personnel prepping welding the welding surface. Caltrans QA Inspector Viars observed ZPMC welder Mr. Tao Qian performing Flux Cored Arc Welding (FCAW) on weld # 4 of Mock-up # 114.00 interior splice plate assembly A75. The following welding parameters were recorded, amperage 290, voltage 30.0, welding travel speed 295 mm/min. and a heat input of 1.76 kJ/mm.
