DEPARTMENT OF TRANSPORTATION

Quality Assurance and Source Inspection

Contract #: 04-0120F4Cty: SF/ALA Rte: 80 PM: 13.2/13.9File #: 69.28**WELDING INSPECTION REPORT****Resident Engineer:** Pursell, Gary**Address:** 333 Burma Road**City:** Oakland, CA 94607**Report No:** WIR-000866**Date Inspected:** 20-Nov-2007**Project Name:** SAS Superstructure**OSM Arrival Time:** 2300**Prime Contractor:** American Bridge/Fluor Enterprises, a JV**OSM Departure Time:** 730**Contractor:** Zhenhua Port Machinery Company, Ltd (ZPMC), Changxing Island **Location:** Shanghai, China**CWI Name:** Chen Xi**CWI Present:** Yes No**Inspected CWI report:** Yes No N/A**Rod Oven in Use:** Yes No N/A**Electrode to specification:** Yes No N/A**Weld Procedures Followed:** Yes No N/A**Qualified Welders:** Yes No N/A**Verified Joint Fit-up:** Yes No N/A**Approved Drawings:** Yes No N/A**Approved WPS:** Yes No N/A**Delayed / Cancelled:** Yes No N/A**Bridge No:** 34-0006**Component:** Caltrans Mock-Up**Summary of Items Observed:**

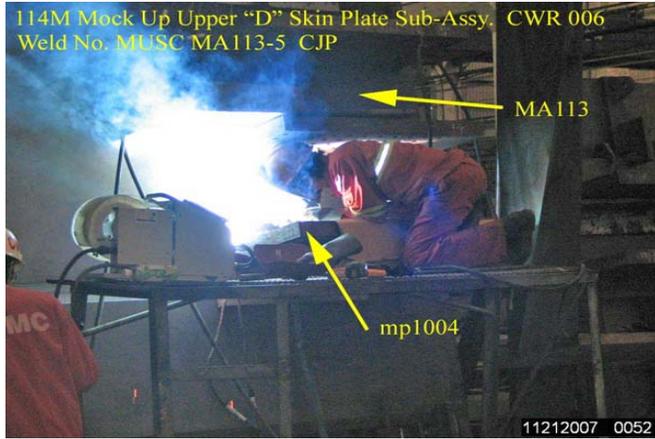
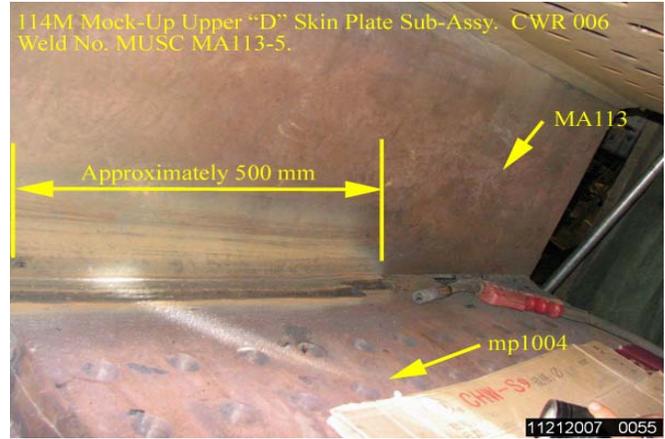
The Caltrans QA Inspector observed the repair welding (Critical Weld Repair No. 006) of Piece Mark mp1004 stiffener to Piece Mark MA113 for the 114M Mock-Up Upper (Top) Plate Panel "D" Sub-Assembly. The weld was identified as MUSC-MA113-5 and is a complete joint penetration (CJP) groove weld welded in the flat (1G) welding position. The welder was Tao Qian (Welder I.D. No. 040457). Welding Procedure Specification (WPS) 345-FCAW-1G(1F)-Repair, for Flux Cored Arc Welding (FCAW) was used for this weld. The Drawing No. is MUSC-MA113, Rev. 0 and the Member ID. is MA113 - mp1004.
