**DEPARTMENT OF TRANSPORTATION**

Contract #: 04-0120F4Cty: SF/ALA Rte: 80 PM: 13.2/13.9File #: 69.28**WELDING INSPECTION REPORT****Resident Engineer:** Pursell, Gary**Address:** 333 Burma Road**City:** Oakland, CA 94607**Report No:** WIR-000888**Date Inspected:** 26-Nov-2007**Project Name:** SAS Superstructure**OSM Arrival Time:** 630**Prime Contractor:** American Bridge/Fluor Enterprises, a JV**OSM Departure Time:** 1530**Contractor:** Zhenhua Port Machinery Company, Ltd (ZPMC), Changxing Island **Location:** Changxing Island**CWI Name:** Chan Woo Lee**CWI Present:** Yes No**Inspected CWI report:** Yes No N/A**Rod Oven in Use:** Yes No N/A**Electrode to specification:** Yes No N/A**Weld Procedures Followed:** Yes No N/A**Qualified Welders:** Yes No N/A**Verified Joint Fit-up:** Yes No N/A**Approved Drawings:** Yes No N/A**Approved WPS:** Yes No N/A**Delayed / Cancelled:** Yes No N/A**Bridge No:** 34-0006**Component:** OBG & 114 Mock-up**Summary of Items Observed:**

# WELDING INSPECTION REPORT

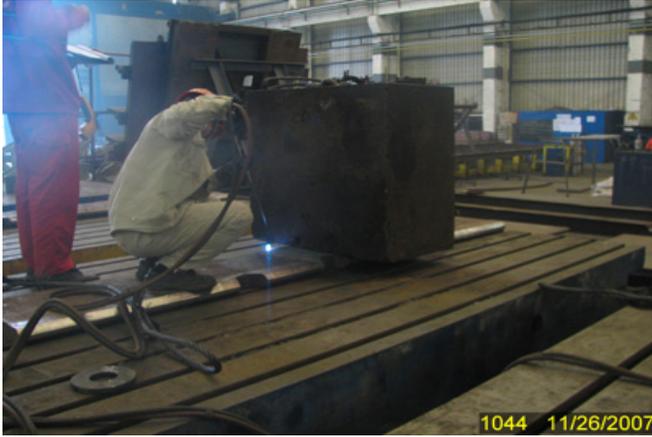
Caltrans QA Inspector Viars observed ZPMC personnel performing Heat straightening of Mock-up 89 Face D Longitudinal plate mp536a to mp536b to mp542. A two ton weight was placed on longitudinal plate while heat straightening was in progress. Caltrans QA inspector Viars informed American Bridge Flour (ABF) representative Mr. Lei Wensheng of the heat straightening with the weight. Mr. Lei Wensheng requested ZPMC personnel

remove the weight before proceeding with heat straightening.
