Contract #: 04-0120F4Cty: SF/ALA Rte: 80 PM: 13.2/13.9File #: 69.28**WELDING INSPECTION REPORT****Resident Engineer:** Pursell, Gary**Address:** 333 Burma Road**City:** Oakland, CA 94607**Report No:** WIR-000901**Date Inspected:** 24-Nov-2007**Project Name:** SAS Superstructure**OSM Arrival Time:** 2300**Prime Contractor:** American Bridge/Fluor Enterprises, a JV**OSM Departure Time:** 730**Contractor:** Zhenhua Port Machinery Company, Ltd (ZPMC), Changxing Island **Location:** Shanghai, China**CWI Name:** Chen Xi**CWI Present:** Yes No**Inspected CWI report:** Yes No N/A**Rod Oven in Use:** Yes No N/A**Electrode to specification:** Yes No N/A**Weld Procedures Followed:** Yes No N/A**Qualified Welders:** Yes No N/A**Verified Joint Fit-up:** Yes No N/A**Approved Drawings:** Yes No N/A**Approved WPS:** Yes No N/A**Delayed / Cancelled:** Yes No N/A**Bridge No:** 34-0006**Component:** Caltrans Mock-Up**Summary of Items Observed:**

WELDING INSPECTION REPORT

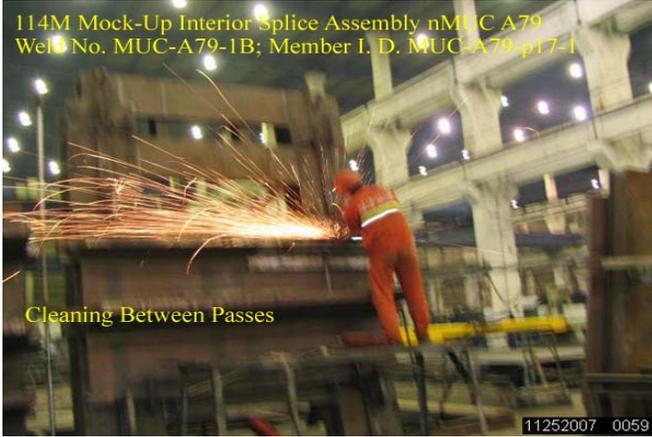
The Caltrans QA Inspector observed welding on Interior Splice Assembly A79 on the 114M Mock-Up. The Drawing No. is MUC-A79, Rev. 0. The weld was identified as MUC-A79-1B and is a complete joint penetration (CJP) groove weld welded in the flat (1G) welding position. Piece Mark A79 was in the vertical position within the plus or minus 30 degrees from vertical permitted by AWS D1.5. The welder was Chang Chuan Cang (Welder I.D. No. 053870). Welding Procedure Specification (WPS) B-T-2231-TC-U5(1G)-F, Rev. 1, for Flux Cored Arc Welding (FCAW) was used for this weld. The Member ID. is A79 - p17-1.
