Contract #: 04-0120F4Cty: SF/ALA Rte: 80 PM: 13.2/13.9File #: 69.28**WELDING INSPECTION REPORT****Resident Engineer:** Pursell, Gary**Address:** 333 Burma Road**City:** Oakland, CA 94607**Report No:** WIR-000904**Date Inspected:** 19-Nov-2007**Project Name:** SAS Superstructure**OSM Arrival Time:** 630**Prime Contractor:** American Bridge/Fluor Enterprises, a JV**OSM Departure Time:** 1530**Contractor:** Zhenhua Port Machinery Company, Ltd (ZPMC), Changxing Island **Location:** Changxing Island**CWI Name:** Art Peterson**CWI Present:** Yes No**Inspected CWI report:** Yes No N/A**Rod Oven in Use:** Yes No N/A**Electrode to specification:** Yes No N/A**Weld Procedures Followed:** Yes No N/A**Qualified Welders:** Yes No N/A**Verified Joint Fit-up:** Yes No N/A**Approved Drawings:** Yes No N/A**Approved WPS:** Yes No N/A**Delayed / Cancelled:** Yes No N/A**Bridge No:** 34-0006**Component:** OBG Deck Plate Trial**Summary of Items Observed:**

Caltrans Quality Assurance (QA) Inspector, Larry Viars was present to observe testing of Orthotropic Box Girder (OBG) Deck Plate Panel Mock-up Trial, for the San Francisco Oakland Bay Self Anchored Suspension Bridge, at Zhenhua Port Machinery Compa

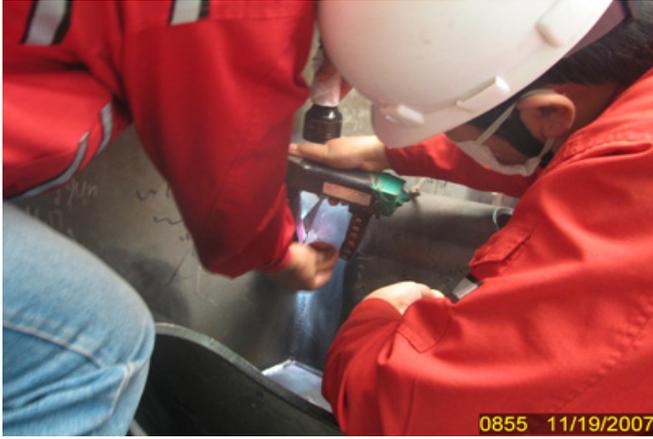
Caltrans QA Inspector witnessed ZPMC QC technicians perform Magnetic Particle Testing (MT) of OBG diaphragm plate to closed rib welds. The area covered by the test was the end of each weld to 50 mm on each side. Please see the attached photo below of the MT performed by Mr. Dongyun. ZPMC QC Mr. Zhou Dongyun performed MT on 100% of the area mentioned above. Caltrans QA Inspector Viars performed random MT of the above mentioned areas.
