Contract #: 04-0120F4Cty: SF/ALA Rte: 80 PM: 13.2/13.9File #: 69.28**WELDING INSPECTION REPORT****Resident Engineer:** Pursell, Gary**Address:** 333 Burma Road**City:** Oakland, CA 94607**Report No:** WIR-000963**Date Inspected:** 01-Dec-2007**Project Name:** SAS Superstructure**OSM Arrival Time:** 1300**Prime Contractor:** American Bridge/Fluor Enterprises, a JV**OSM Departure Time:** 2330**Contractor:** Zhenhua Port Machinery Company, Ltd (ZPMC), Changxing Island **Location:** Shanghai, China

WELDING INSPECTION REPORT

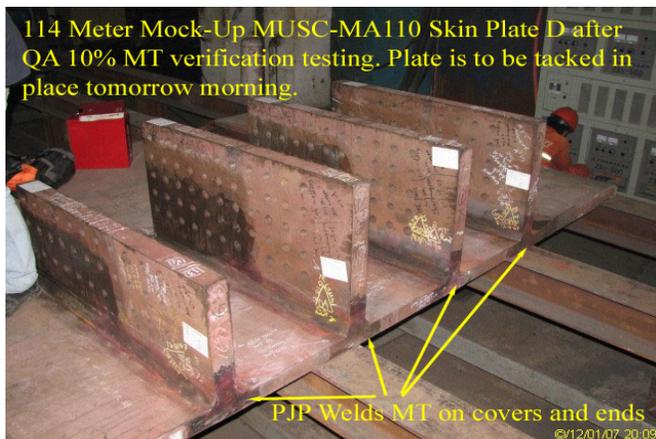
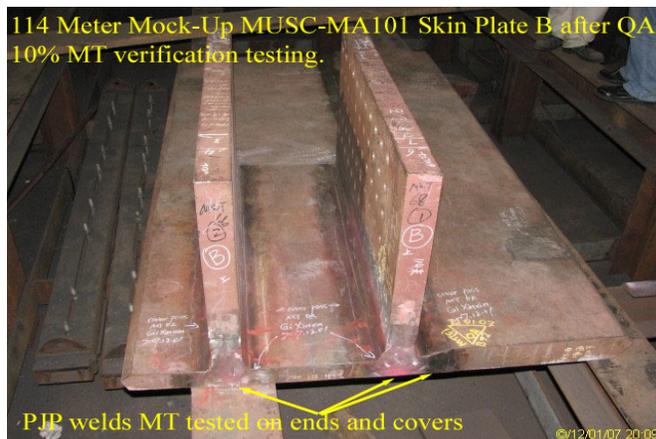
This Quality Assurance Inspector witnessed ZPMC magnetic particle technician Cai Xinxin performing magnetic particle testing of the root welds for MUSB-MA21 Skin Plate 'A' Sub-Assembly on partial joint penetration welds 3 & 15. This Quality Assurance Inspector also performed 10% verification testing on these welds. For details of the magnetic particle testing see TL 6028 dated December 01, 2007.

This Quality Assurance Inspector performed magnetic particle testing of the final welds for MUSC-MA110 Skin Plate 'D' Sub-Assembly on partial joint penetration welds 1, 4, 5, 7, 8, 10, 11, 13 & 14 and on MUSC-MA101 Skin Plate 'B' Sub-Assembly on partial joint penetration welds 1, 3, 4, 6 & 7. Inspections include the cover passes and weld ends. For details of the magnetic particle testing see TL 6028 dated December 01, 2007.
