**DEPARTMENT OF TRANSPORTATION**

Contract #: 04-0120F4Cty: SF/ALA Rte: 80 PM: 13.2/13.9File #: 69.28**WELDING INSPECTION REPORT****Resident Engineer:** Pursell, Gary**Address:** 333 Burma Road**City:** Oakland, CA 94607**Report No:** WIR-001012**Date Inspected:** 13-Dec-2007**Project Name:** SAS Superstructure**OSM Arrival Time:** 2200**Prime Contractor:** American Bridge/Fluor Enterprises, a JV**OSM Departure Time:** 730**Contractor:** Zhenhua Port Machinery Company, Ltd (ZPMC), Changxing Island **Location:** Shanghai, China**CWI Name:** Chen Xi**CWI Present:** Yes No**Inspected CWI report:** Yes No N/A**Rod Oven in Use:** Yes No N/A**Electrode to specification:** Yes No N/A**Weld Procedures Followed:** Yes No N/A**Qualified Welders:** Yes No N/A**Verified Joint Fit-up:** Yes No N/A**Approved Drawings:** Yes No N/A**Approved WPS:** Yes No N/A**Delayed / Cancelled:** Yes No N/A**Bridge No:** 34-0006**Component:** CalTrans mock up**Summary of Items Observed:**

# WELDING INSPECTION REPORT

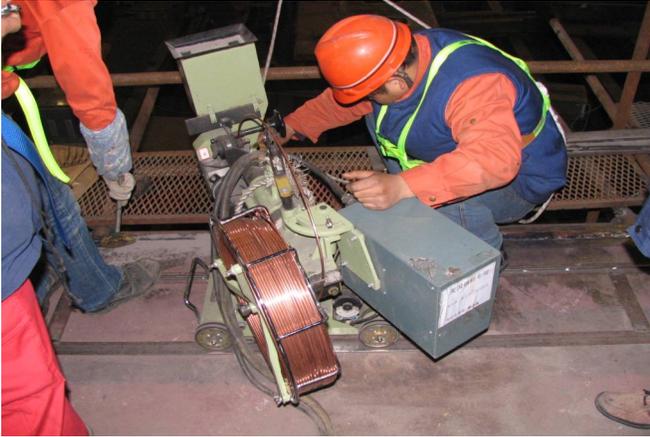
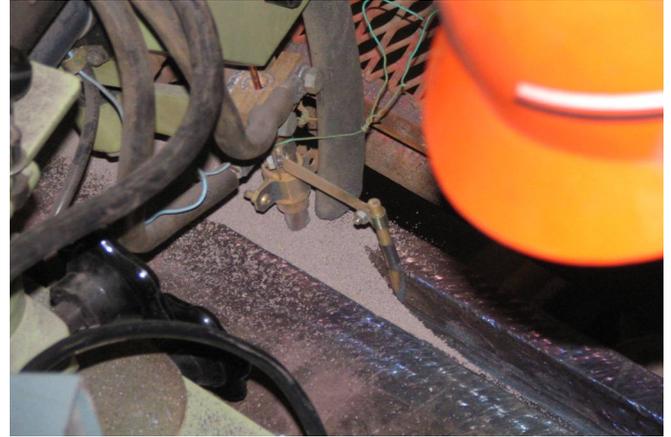
Caltrans QA Inspector observed Submerged arc welding (SAW) in progress of the corner connection weld of muc-ma107, skin plate E musc-ma108 to skin plate D musc-ma110, weld joint 1A. The weld joint is a Complete Joint Penetration (CJP), double bevel corner joint. The welder was observed welding root pass in the 1G position using a chipping hammer and wire brushing to clean weld pass. The approved welder is identified as Mr. Yun Chuan Jin # 0503060 using approved welding procedure specification WPS-B-T-2221-C-U2b-S. QA Inspector measured current welding parameters at approximately 639 amps, 33.8 volts and 708 millimeters per minute (mm/min) travel speed. Preheat and interpass temperatures were verified during welding activities and were within approved WPS minimum and maximum range. SAW welding consumable is verified and identified as EM12K JW3 4.8mm diameter using JF-B flux. ZPMC Quality Control (QC) Inspector, Certified Welding Inspector (CWI) Mr. Chen Xi was observed monitoring welding activities at the workstation. QC Inspector is using drawing MUC-MA106 C/C Upper Shaft Assembly resulting in incorrectly reporting of part numbers in the weld log. The 114m Lower Shaft assembly drawing is MUC-MA107.

QA Inspector informed QC Inspector Mr. Chen Xi that he was using the incorrect drawing for the welding in progress. QC Inspector stated he was using the correct drawing because of a hand written note at the bottom of drawing MUC-MA106 C/C which stated "down tower" but would verify with ABF.
