Quality Assurance and Source Inspection

Contract #: 04-0120F4Cty: SF/ALA Rte: 80 PM: 13.2/13.9File #: 69.28**WELDING INSPECTION REPORT****Resident Engineer:** Pursell, Gary**Address:** 333 Burma Road**City:** Oakland, CA 94607**Report No:** WIR-001039**Date Inspected:** 20-Dec-2007**Project Name:** SAS Superstructure**OSM Arrival Time:** 2300**Prime Contractor:** American Bridge/Fluor Enterprises, a JV**OSM Departure Time:** 730**Contractor:** Zhenhua Port Machinery Company, Ltd (ZPMC), Changxing Island **Location:** Shanghai, China**CWI Name:** Lu Lefeng, Sha Zhi**CWI Present:** Yes No**Inspected CWI report:** Yes No N/A**Rod Oven in Use:** Yes No N/A**Electrode to specification:** Yes No N/A**Weld Procedures Followed:** Yes No N/A**Qualified Welders:** Yes No N/A**Verified Joint Fit-up:** Yes No N/A**Approved Drawings:** Yes No N/A**Approved WPS:** Yes No N/A**Delayed / Cancelled:** Yes No N/A**Bridge No:** 34-0006**Component:** Caltrans Mock-Up**Summary of Items Observed:**

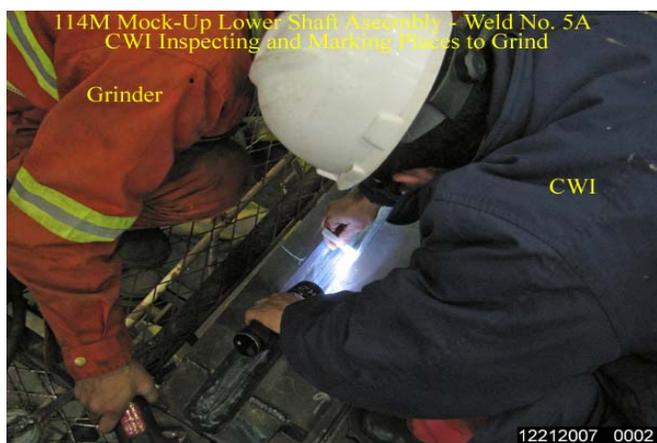
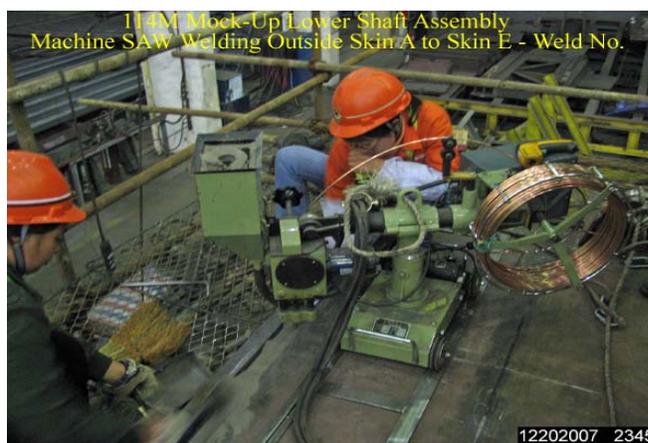
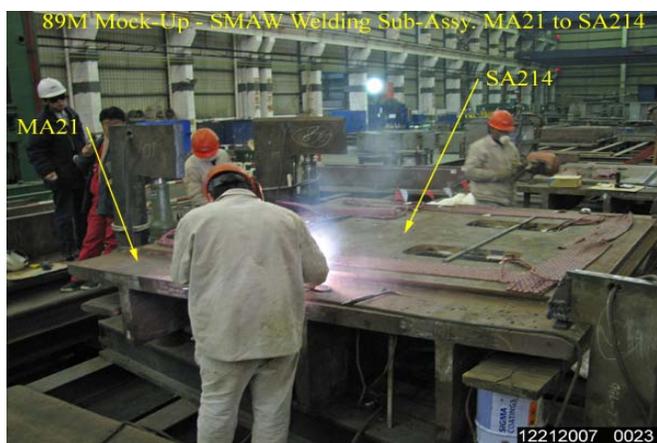
The Caltrans QA Inspector observed the Machine Submerged Arc Welding (SAW) on the Lower Shaft Assembly of the 114M Mock-Up, Weld No. MUC-MA107 B/C-5A. This is the outside weld of Skin A to Skin E. This is a complete joint penetration (CJP) groove weld and was being welded in the flat groove (1G) welding position. The welding operator was Xu Yan (I.D. No. 052917), whose qualifications for this welding are listed in ZPMC's Master List of Welders/Welding Operators/Tack Welders, Revision 7. Welding Procedure Specification (WPS) WPS-B-T-2221-C-U2b-S was being used for this weld. ZPMC CWI, Lu Lefeng (CWI No. 07031411) was present during welding as was Bureau Veritas Inspector, Li Wen Shang. The QA Inspector also noted that ZPMC's documentation of minimum/maximum preheat/interpass temperatures, voltage, amperage and travel speed by the CWI were within the specified ranges of the WPS for the passes welded up until the time of observation. The QA Inspector also randomly measured the above four parameters by use of a calibrated Fluke amp/volt meter for amperage and voltage, temperature indicating crayons for preheat/interpass temperature, and a tape measure and stop watch for travel speed.

The Caltrans QA Inspector also observed the Manual Shielded Metal Arc Welding (SMAW) joining Sub-Assembly MA21 to Sub-Assembly SA214 on the 89M Mock-Up. There were a total of five welders making four welds, Weld Nos. MUB-MA21-C/J-1, 2, 3, 4. These are partial joint penetration (PJP) groove welds and were being welded in the horizontal groove (2G) welding position. The five welders were He Shibing (I.D. No.

All observations appeared to meet the requirements of the job specifications.
