DEPARTMENT OF TRANSPORTATION

Contract #: 04-0120F4Cty: SF/ALA Rte: 80 PM: 13.2/13.9File #: 69.28**WELDING INSPECTION REPORT****Resident Engineer:** Pursell, Gary**Address:** 333 Burma Road**City:** Oakland, CA 94607**Report No:** WIR-001128**Date Inspected:** 29-Nov-2007**Project Name:** SAS Superstructure**OSM Arrival Time:** 630**Prime Contractor:** American Bridge/Fluor Enterprises, a JV**OSM Departure Time:** 1530**Contractor:** Zhenhua Port Machinery Company, Ltd (ZPMC), Changxing Island **Location:** Changxing Island

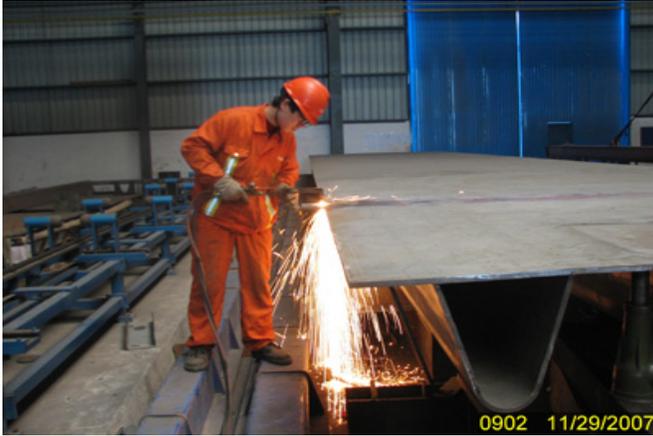
Caltrans QA Inspector Viars observed ZPMC personnel removing run off tabs for the OBG deck plate trial splice weld # MU1-1-11. The QA inspector observed that Ultrasonic, Magnetic Particle and Radiographic Testing was completed prior to the removal of the run off tabs. Warpage of the deck plate was noted on the 1.7 meter section of the deck trial at U-rib u-06 and U-07. Caltrans QA Inspector Viars was informed by American Bridge Flour representative Mr. Art Peterson that the deck plate was out of tolerance on flatness dimensions and that a heat straightening request would be forthcoming to Caltrans Engineering. Mr. Peterson stated that Nondestructive Testing would be performed again on the deck plate splice weld once the heat straightening request was approved. Please see the attached photo of the run off tab removal of Deck plate trial.
