**DEPARTMENT OF TRANSPORTATION**

Contract #: 04-0120F4Cty: SF/ALA Rte: 80 PM: 13.2/13.9File #: 69.28**WELDING INSPECTION REPORT****Resident Engineer:** Pursell, Gary**Address:** 333 Burma Road**City:** Oakland, CA 94607**Report No:** WIR-001160**Date Inspected:** 01-Jan-2008**Project Name:** SAS Superstructure**OSM Arrival Time:** 630**Prime Contractor:** American Bridge/Fluor Enterprises, a JV**OSM Departure Time:** 1530**Contractor:** Zhenhua Port Machinery Company, Ltd (ZPMC), Changxing Island **Location:** Shanghai, China**CWI Name:** See Below**CWI Present:** Yes No**Inspected CWI report:** Yes No N/A**Rod Oven in Use:** Yes No N/A**Electrode to specification:** Yes No N/A**Weld Procedures Followed:** Yes No N/A**Qualified Welders:** Yes No N/A**Verified Joint Fit-up:** Yes No N/A**Approved Drawings:** Yes No N/A**Approved WPS:** Yes No N/A**Delayed / Cancelled:** Yes No N/A**Bridge No:** 34-0006**Component:** Tower and OBG Fabrication**Summary of Items Observed:**

## WELDING INSPECTION REPORT

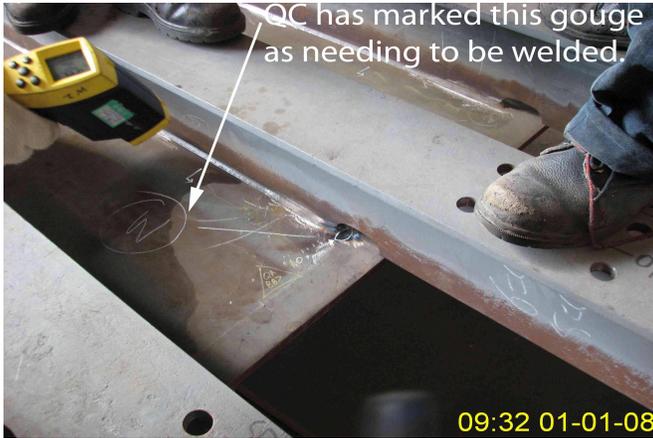
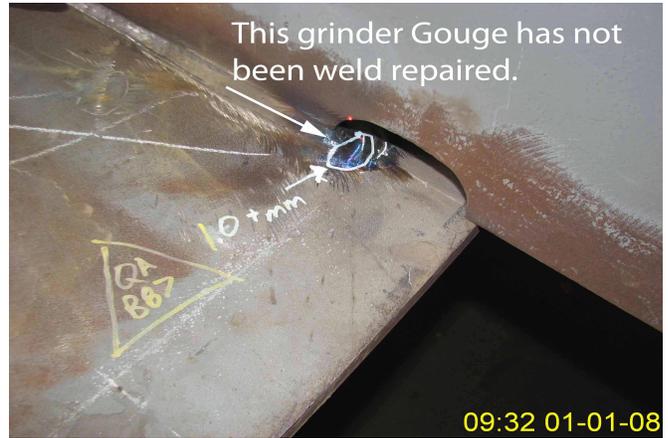
The QA Inspector performed random visual inspections of portions of stiffener plate welds on OBG side plate SP075. The QA Inspector observed the east end of the bottom toe of the fillet weld on stiffener plate SP075-01-018 has an area that has been ground to a depth of approximately 1mm below flush. This grind area had previously been identified and marked with a triangle by Caltrans QA Personnel and no repairs have been made to this location. The QA Inspector asked ZPMC QC Inspector Mr. Wu Ming Kai if he had observed the ground area and after Mr. Kai measured the grind area he informed the QA Inspector that this area will need to be weld repaired. See the photograph below for additional information.

The QA Inspector observed ZPMC welder Mr. Li Schuliang stencil 48801 is using welding procedure specification WPS-345-FCAW-1G(1F)-Repair using the flux cored welding process to make a repair of the weld gouge on the end of OBG side plate SP075 at the east end of stiffener plate SP075-01-018. The QA Inspector observed Mr. Schuliang using 1.4 mm diameter E71T-1 welding electrode with a welding current of approximately 280 amps, 28.0 volts and the base material has a minimum preheat of 160° C. Items observed by the QA Inspector appear to comply with project specifications.
