Contract #: 04-0120F4Cty: SF/ALA Rte: 80 PM: 13.2/13.9File #: 69.28**WELDING INSPECTION REPORT****Resident Engineer:** Pursell, Gary**Address:** 333 Burma Road**City:** Oakland, CA 94607**Report No:** WIR-001162**Date Inspected:** 30-Dec-2007**Project Name:** SAS Superstructure**OSM Arrival Time:** 830**Prime Contractor:** American Bridge/Fluor Enterprises, a JV**OSM Departure Time:** 1730**Contractor:** Zhenhua Port Machinery Company, Ltd (ZPMC), Changxing Island **Location:** Shanghai, China**CWI Name:** See Below**CWI Present:** Yes No**Inspected CWI report:** Yes No N/A**Rod Oven in Use:** Yes No N/A**Electrode to specification:** Yes No N/A**Weld Procedures Followed:** Yes No N/A**Qualified Welders:** Yes No N/A**Verified Joint Fit-up:** Yes No N/A**Approved Drawings:** Yes No N/A**Approved WPS:** Yes No N/A**Delayed / Cancelled:** Yes No N/A**Bridge No:** 34-0006**Component:** Tower and OBG Fabrication**Summary of Items Observed:**

Orthotropic Box Girder (OBG) and Tower Mock Up:

WELDING INSPECTION REPORT

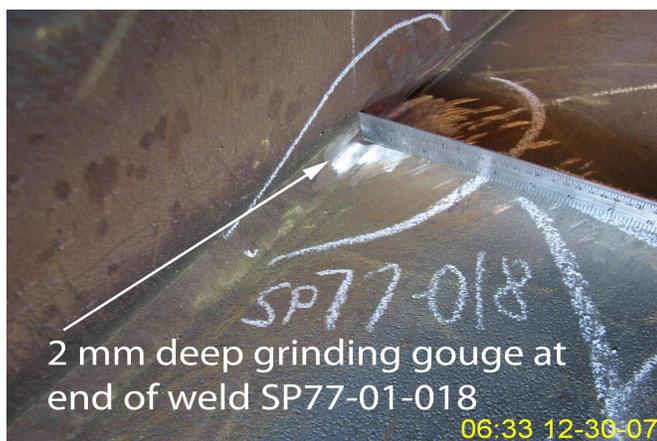
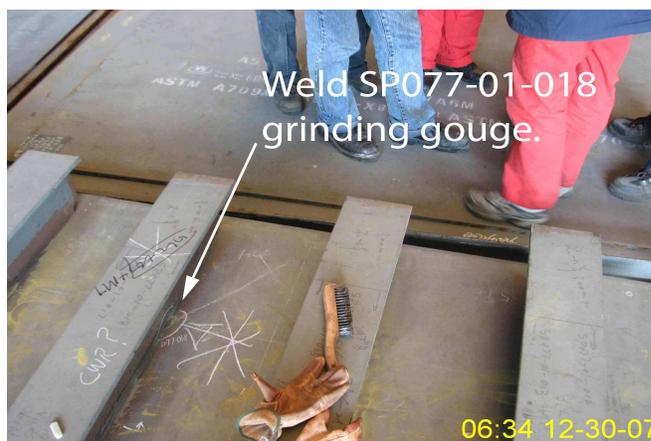
ZPMC QC/CWI Inspector Mr. Xu Xian Ping informed the QA Inspector that ZMPC has completed visual of the fillet welds between stiffener plates and bottom plate SP077 and these welds are QC acceptable. Mr. Ping said ZPMC is almost completed with the magnetic particle (MT) inspections of these welds. The QA Inspector performed random visual inspection of weld SP077-01-018 and observed a 2 mm deep grinding gouge adjacent to the lower toe of the weld and 1mm deep in the stiffener plate. The QA Inspector asked Mr. Ping if QC had previously observed this grinding gouge and Mr. Ping said this gouge had been made when a crack had been removed following magnetic particle inspection of the weld. Mr. Ping said ZPMC will need to process a critical weld repair prior to performing a weld repair of the gouge. See the photographs below for additional information.
