DEPARTMENT OF TRANSPORTATION

Quality Assurance and Source Inspection

Contract #: 04-0120F4Cty: SF/ALA Rte: 80 PM: 13.2/13.9File #: 69.28**WELDING INSPECTION REPORT****Resident Engineer:** Pursell, Gary**Address:** 333 Burma Road**City:** Oakland, CA 94607**Report No:** WIR-001177**Date Inspected:** 06-Jan-2008**Project Name:** SAS Superstructure**OSM Arrival Time:** 630**Prime Contractor:** American Bridge/Fluor Enterprises, a JV**OSM Departure Time:** 1530**Contractor:** Zhenhua Port Machinery Company, Ltd (ZPMC), Changxing Island **Location:** Changxing Island**CWI Name:** Ye Yong Jun**CWI Present:** Yes No**Inspected CWI report:** Yes No N/A**Rod Oven in Use:** Yes No N/A**Electrode to specification:** Yes No N/A**Weld Procedures Followed:** Yes No N/A**Qualified Welders:** Yes No N/A**Verified Joint Fit-up:** Yes No N/A**Approved Drawings:** Yes No N/A**Approved WPS:** Yes No N/A**Delayed / Cancelled:** Yes No N/A**Bridge No:** 34-0006**Component:** Caltrans Mock-up**Summary of Items Observed:**

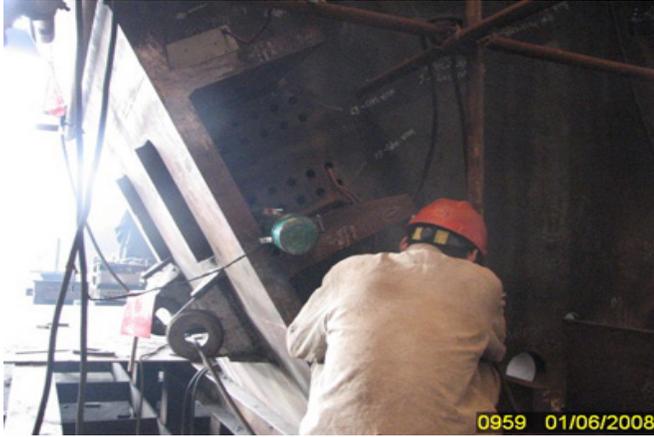
Caltrans QA Inspector observed ZPMC welder Guo Dengyun performing Shielded Metal Arc Welding (SMAW) on Mock-up 77.00 weld # 62, 63 and 66 in accordance with WPS-B-T-4313-TC-P4-1. Please the attached photo of stiffener to diaphragm welding.
