DEPARTMENT OF TRANSPORTATION

Contract #: 04-0120F4Cty: SF/ALA Rte: 80 PM: 13.2/13.9File #: 70.28**WELDING INSPECTION REPORT****Resident Engineer:** Pursell, Gary**Address:** 333 Burma Road**City:** Oakland, CA 94607**Report No:** WIR-001214**Date Inspected:** 09-Jan-2008**Project Name:** SAS Superstructure**OSM Arrival Time:** 830**Prime Contractor:** American Bridge/Fluor Enterprises, a JV**OSM Departure Time:** 1930**Contractor:** Japan Steel Works**Location:** Muroran, Japan**CWI Name:****CWI Present:**

Bridge No: 34-0006**Component:** West Deviation Saddle Segment W2E2**Summary of Items Observed:**

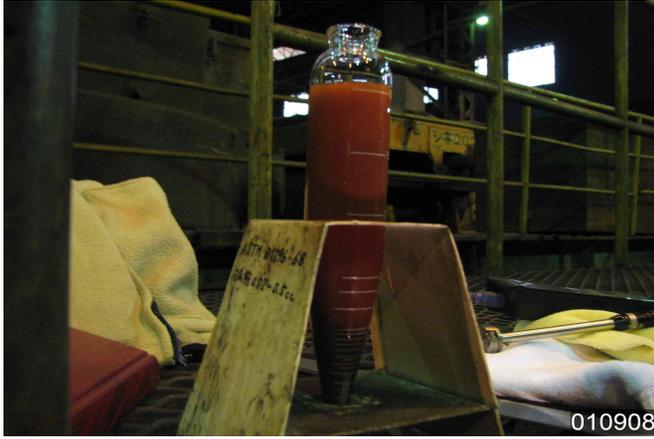
First, the technician used 10 liter water mixed with 1kg non-fluorescent red magnetic particles in a container for 10 minutes. Next, the mixed wet suspension particle samples have been filled into a measureable glass container for settling volumes standard (See photo. The settling volumes indicated on glass container was 2.0 ml (ASME standard from 1.2 ml to 2.4 ml per 100ml). Then, the technician performed wet MT test, the wet suspension particle carrier by a squeeze bottle. The wet suspension particles are gently sprayed out and flowed over the surface of the test part quickly and easily covered with a relatively uniform layer of particles. The magnetizing force applied immediately after applying the wet suspension particles. The use of wet suspension particles is useful for detecting slight discontinuities on the smooth surface such as after machining. The MT test was completed at 15:00 and no relative indication was found on the test surface.
